Here's the final report for our project: "Enhancing Connectivity in the Androscoggin River, ME, a NFHAP Project for EBTJV Intact Sub-Watersheds", grant # F10AP00263 (formerly #53371-A-G002).

Eastern Brook Trout Joint Venture Completed Project Report Form

Project Title: Enhancing connectivity in the Androscoggin River, ME, NFHAP Project for EBTJV intact sub-watersheds. (Project #F10AP00263)

Cat Alley Brook - Route 26 Box Culvert Renovation

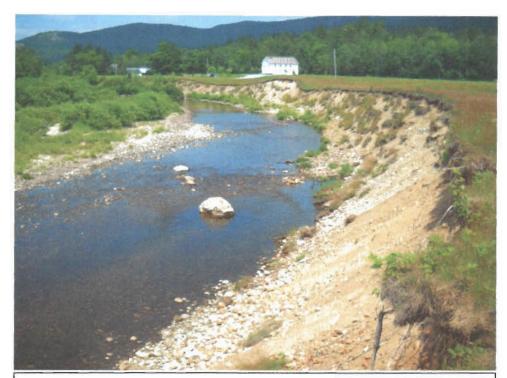
July 6, 2010, Bear River Grange, prior to construction. View upstream. Photograph by Jeff Stern, Androscoggin River Watershed Council.

- Methods used: In order to make improvements at the Bear River Grange site (objective #1), an excavator was used to install eight rock vanes that extended from the bank into the river. These vanes (also called "deflectors") point upstream, and reroute flows away from the vulnerable bank. They also improve aquatic habitat by creating pools, causing the river to narrow, and diversifying habitat conditions and velocities. The vanes were keyed into the bank and sloped down to the river so they will be effective at varying water levels. The steep bank was graded to a gentler slope in places. The toe of the bank was further stabilized by adding 15 debris jams ("bar buddies") between the rock vanes. These trees were anchored to boulders or "anchor" trees that were sunk into the stream bed by cable. The debris jams offer additional bank protection and provide cover for fish. Finally the formerly bare bank was seeded with fast-growing winter rye, and then planted with seedling white pine. (ARWC plans additional tree plantings on the bank in 2013.) Work was completed in August 2010. Permits to do this work were

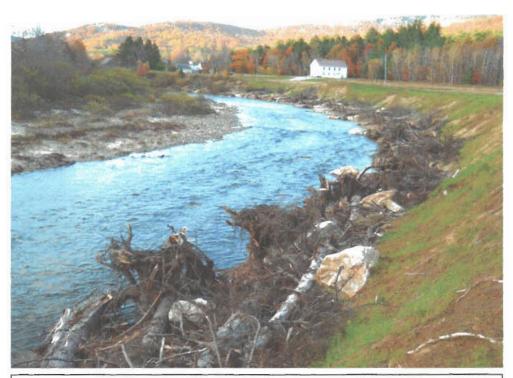
October 18, 2010, Bear River Grange, after construction. Photograph by Jeff Stern, Androscoggin River Watershed Council.

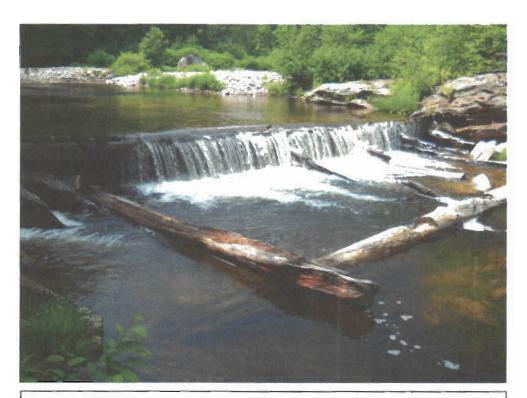
July 12, 2011, Site #D 1028. The remains of a log driving dam on the mainstem of the Sunday River in Riley Township, Maine, photograph by Jeff Stern, Androscoggin River Watershed Council. This was the number 1 priority site for removal after the barrier assessment was conducted in the Sunday River and Bear River sub-watersheds. Removal will open an estimated four miles of the upper Sunday River and headwater tributaries to brook trout movement, migration and colonization. The Watershed Council is working with the Maine Department of Inland Fisheries & Wildlife, and the Maine Bureau of Parks & Lands, to remove this barrier, hopefully in 2013. An application has been submitted to the Eastern Brook Trout Joint Venture for a grant to provide funding for removal.

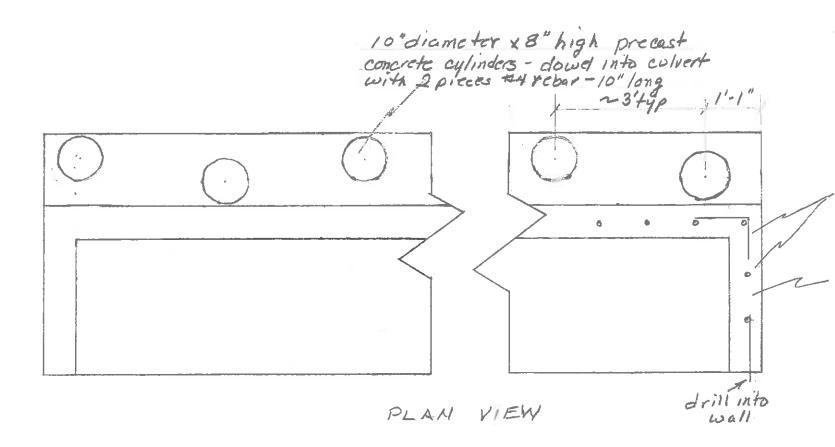
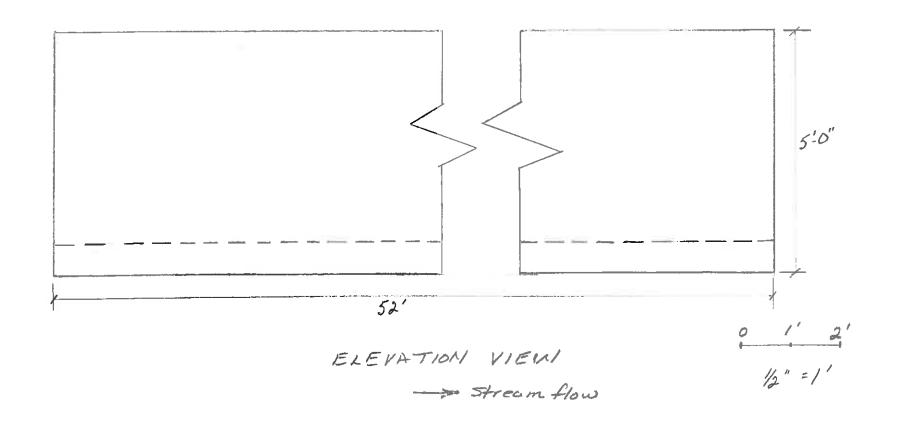
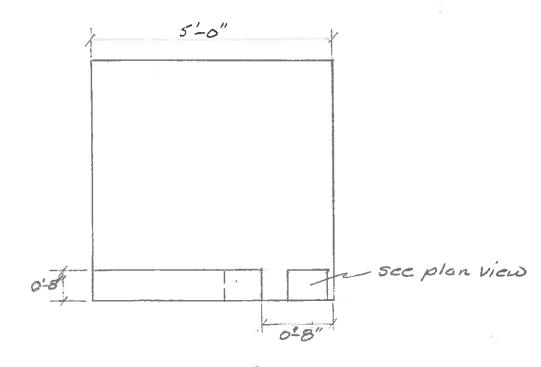
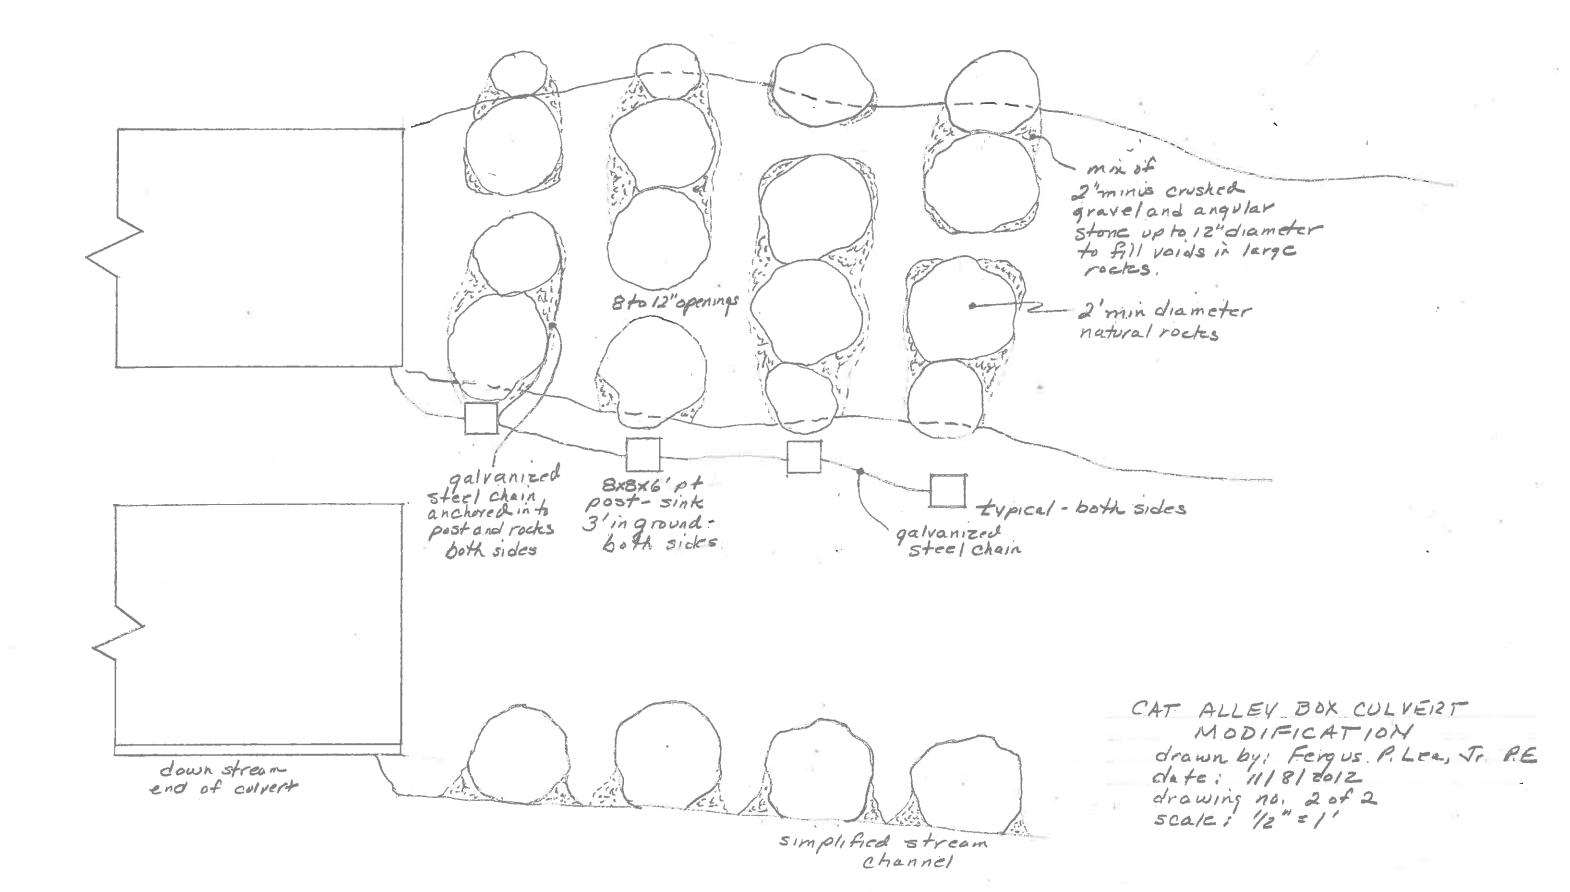
CAT ALLEY BIZOOK CULVERT MODIFICATION

Box Culvert: The box culvert has a smooth concrete bottom and a perched outlet that is approximately one foot above the stream bed. The stream drops away from the outlet at a moderate slope. Several changes are necessary to provide for fish passage. The design provided is meant to provide passage at the average low flow condition of the brook. The renovations include:

- 1. Construct a berm inside the culvert to create a smaller channel for low flow conditions. The width of channel is sized to approximate the size of the typical stream channel section which the brook follows during low flow conditions.

- 2. Place a series of artificial stones in the newly created channel to create small eddies to enable fish to rest behind them on their journey through the culvert. Ideally, the bottom of the newly created channel could be resurfaced with a layer of 3 inch minus stone embedded in a layer of concrete in order to simulate a more natural streambed. However, this would be quite expensive to properly anchor and could reduce the hydraulic capacity of the culvert significantly. It would also create a larger drop at the outlet that would have to be overcome.

- 3. Install a series of weirs below the box culvert to create small openings for water flow and pond water behind them. The stream would be stepped down (as it flows towards the Bear River) through a series of openings that create drops of no more than 4 to 5 inches. Openings should be approximately one foot wide. In order to maintain hydraulic capacity and as natural a setting as possible, the weirs are constructed of large boulders (2 to 3 feet in diameter) filled around by a combination of crushed stone having a D50 of 12 inches and crushed 4 inch minus gravel. The first row of boulders should not have an elevation that is more than 8" above the floor of the box culvert. The boulders would be anchored together with a system of galvanized steel chain that would be attached to the box culvert and a series of 8"x8"x6' pressure treated posts sunk into the stream bank on both sides of the boulder weirs. The chain would be fastened to the boulders in

#4 bar - flush with top of berm and 2" min into culvert

8"x8" concrete berm. Cut 1" x1" deep key slot in bottom of box culvett.

Dowel in place with #4 rebar centered in berm and drilled into box culvert.

Dowels placed 12" o.c. Secure corners with 2 pieces L #4 rebar 12" each leg and placed horizontally.

Dowel berm ends into vertical culvert walls. 2 pieces 2" plus into wall and 8" into berm.

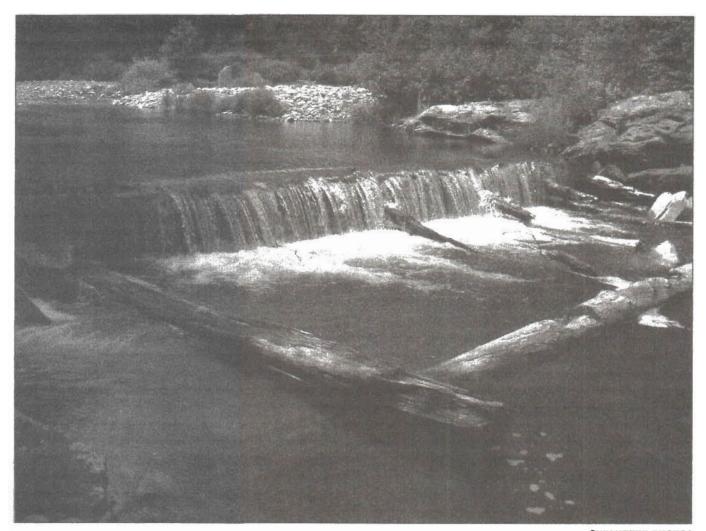
Officials from Maine agencies plan to remove this old log-driving dam remnant from the Sunday River in Riley Township this summer after it was identified last year as a significant barrier to brook trout movement.
