Eastern Brook Trout Joint Venture Completed Project Report Form

Great Pond Tributary Culvert Replacement, Little Cards Brook, Franklin, Maine

- **Sponsor: Hancock County Soil and Water Conservation District**

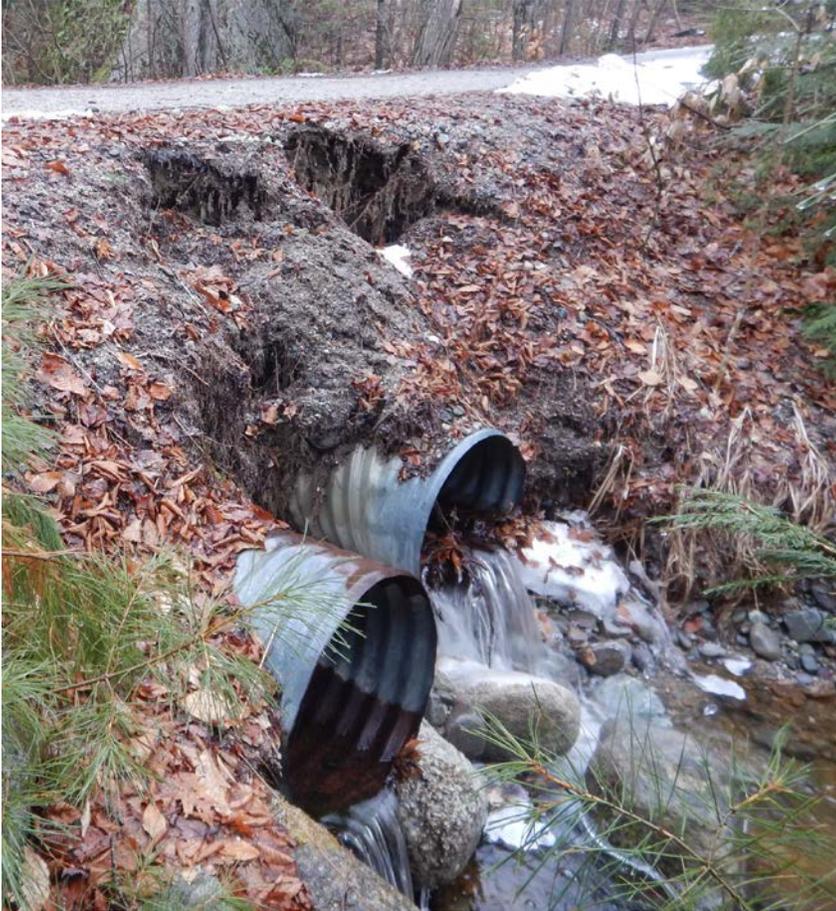
The project met the habitat objectives of removing an aquatic passage barrier and restoring access to an additional ¼ mile of cold water refugia. It also met watershed management goals of replacing two undersized and chronically failing culverts with, a structure that is properly sized greatly reducing the likely hood of failure and associate erosion washing sediment down stream and increasing nutrient loading in Great Pond. We learned that the project would have benefited from having run storm event calculations to eliminate structural choices before requesting funding. The proposed open arch design was inadequate to address 100 year storm events. The final rectangular structure was able to pass the storm events but was also more costly. In the future, I would recommend more preliminary design before requesting funding, or providing contingency funding process. The Nature Conservancy ability to provide additional funding allowed this project to be completed.

1: Before: culvert outlet w/ erosion after fall storm

The undersized hanging culverts were replaced with a open bottom precast concrete structure. That is over 1.2 times bankfull width and capable of passing a 100 year storm at 80% capacity of the structure.

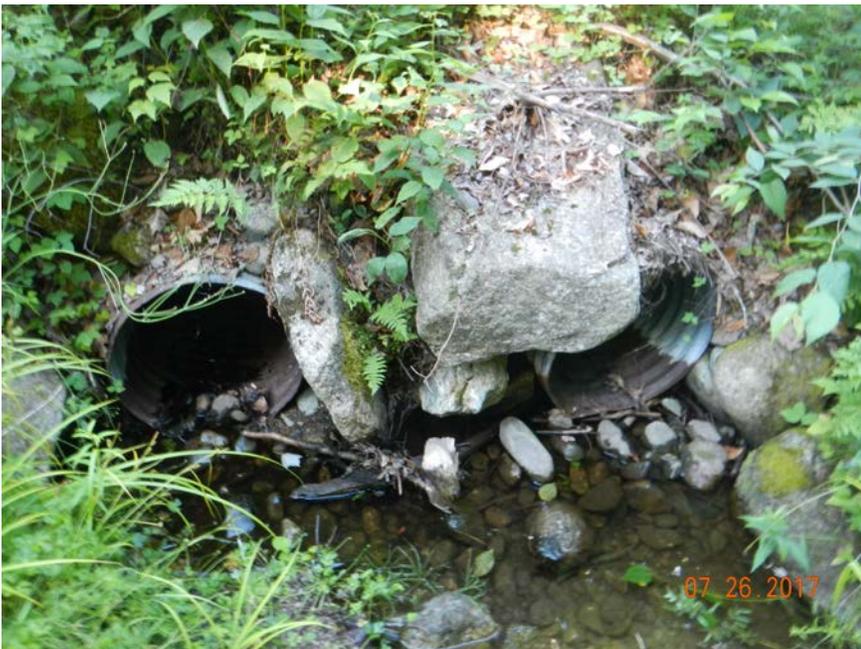
2: Before: culvert inlet

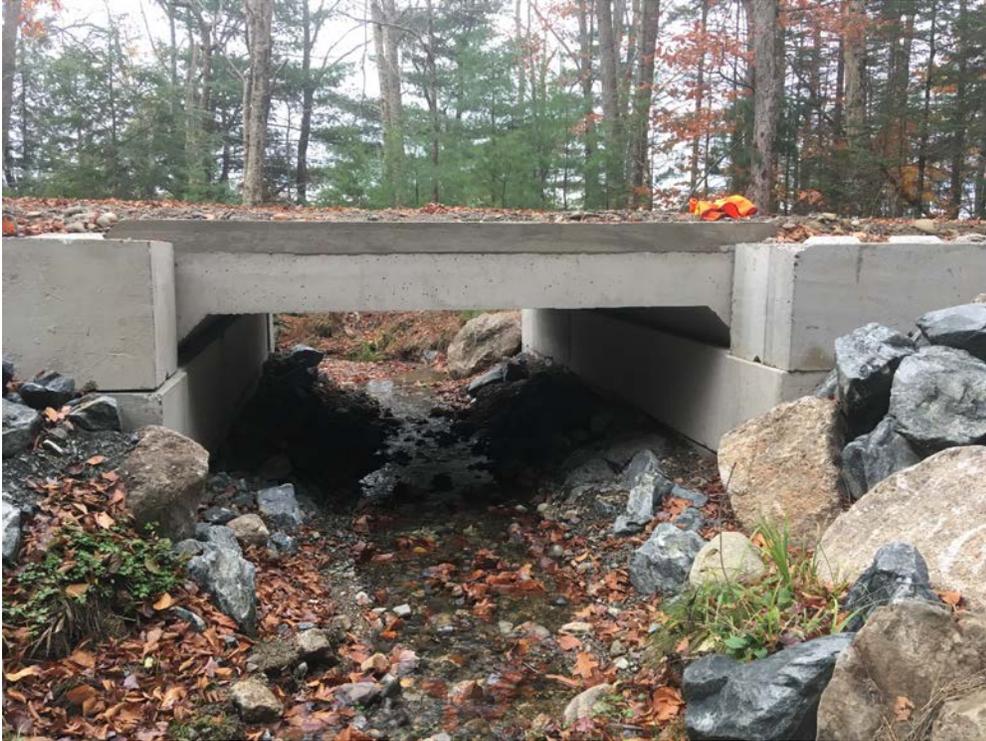
3. After inlet looking down stream

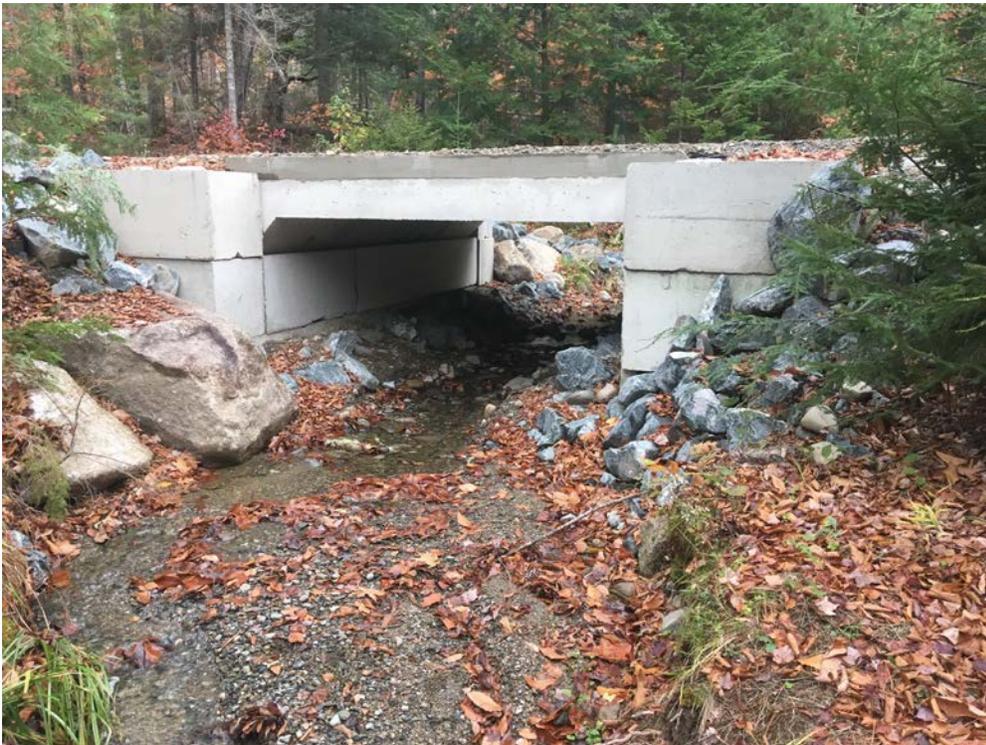
4. After, outlet looking up-stream

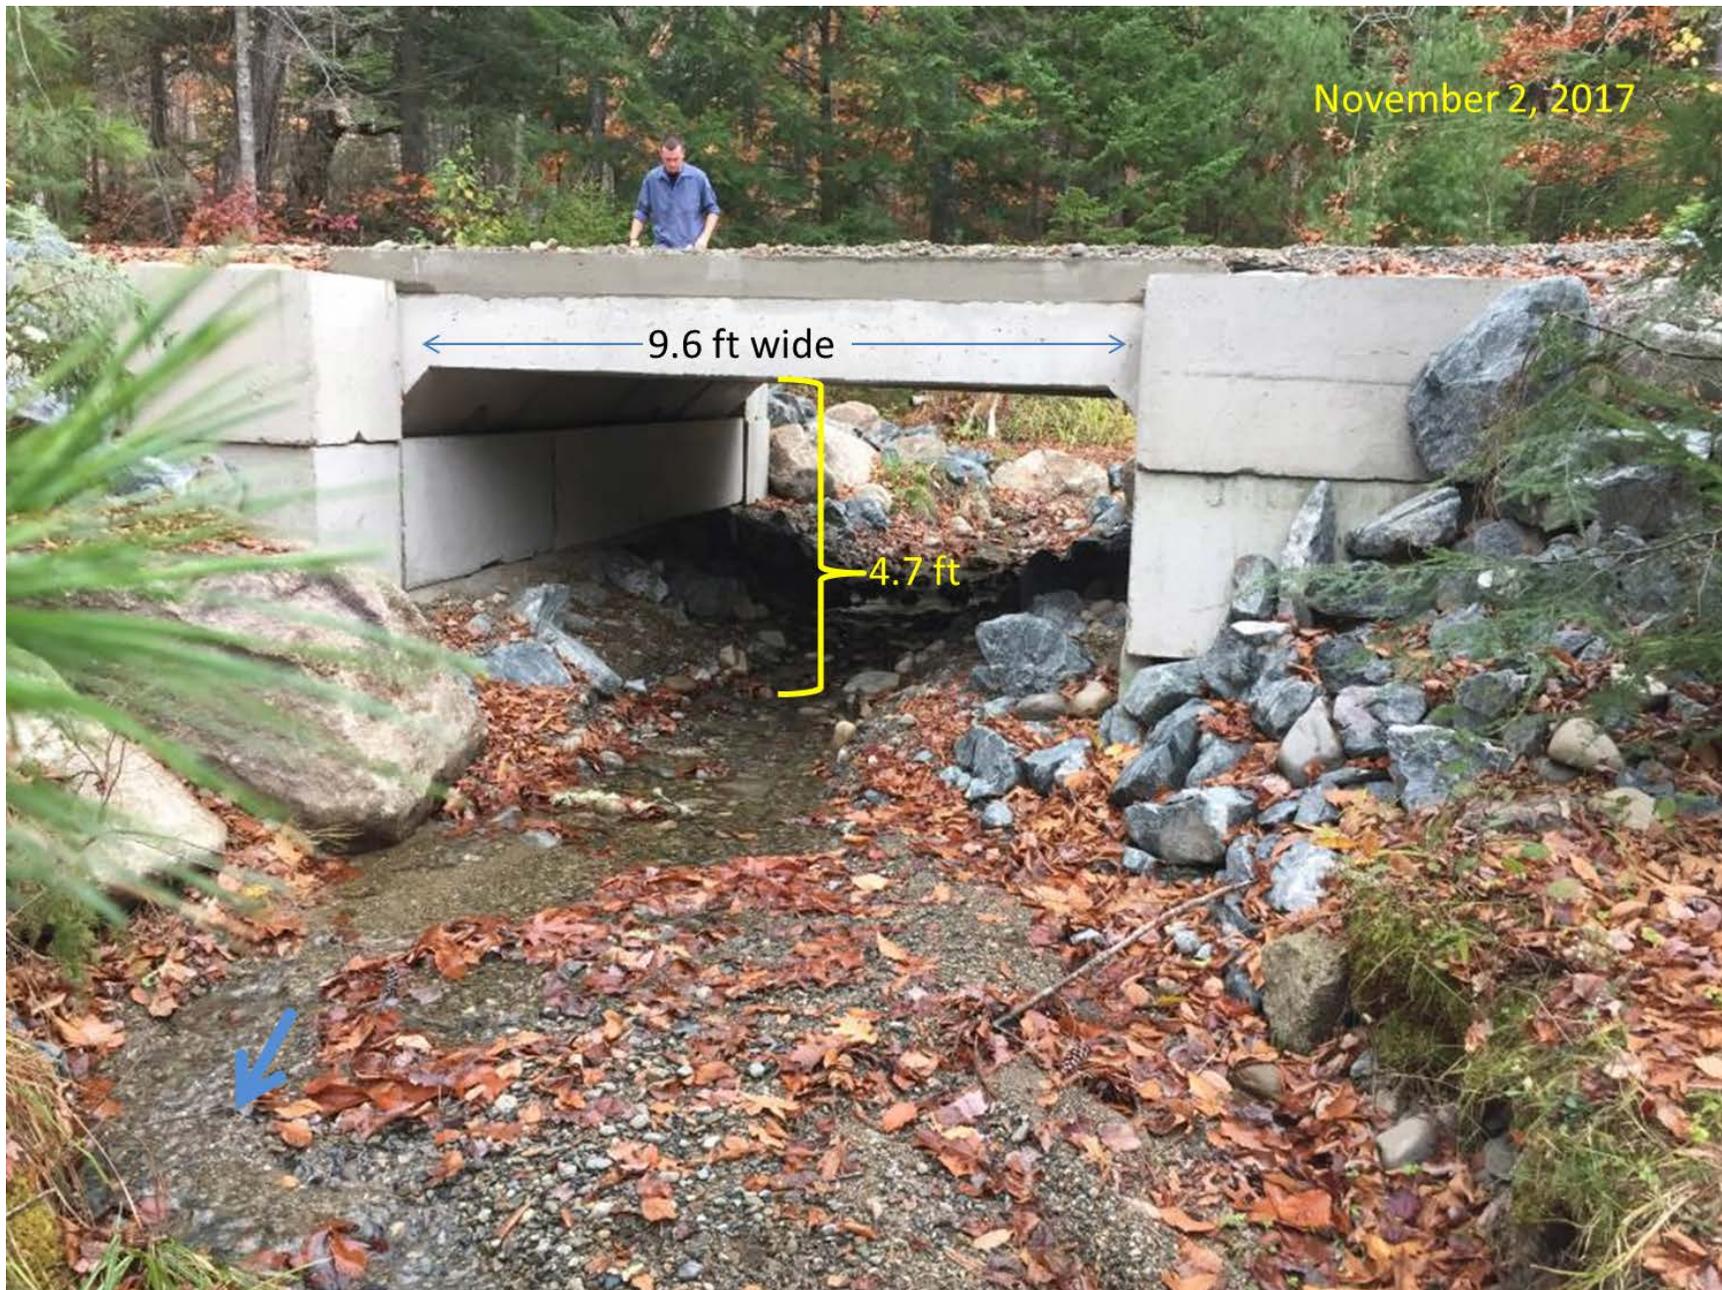
← 9.6 ft wide →

4.7 ft
