Eastern Brook Trout Joint Venture

Final Project Report

Rehabilitation of an Unnamed sea-run brook trout stream, Belfast, Maine

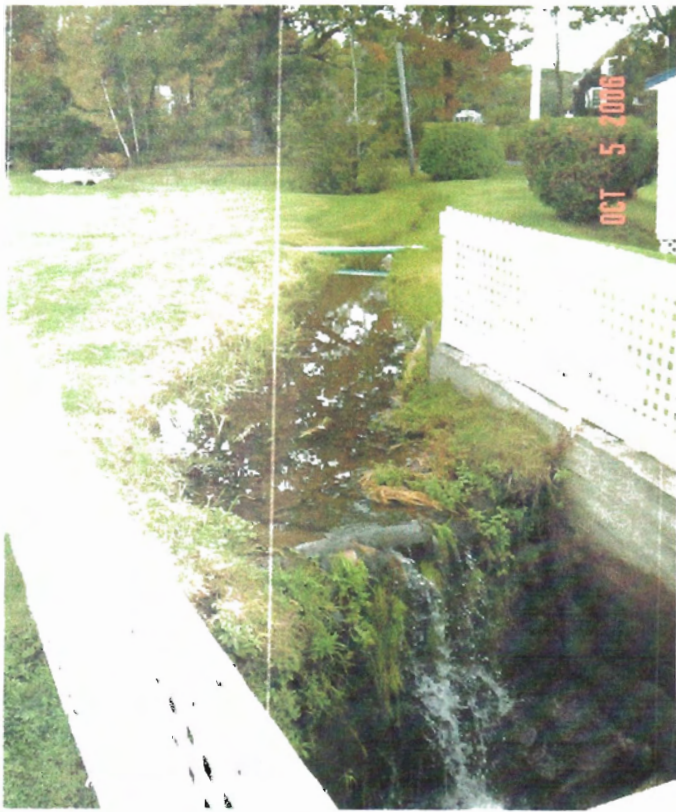
Belfast, Maine: Unnamed Stream, existing dam and view of stream channel.
Photograph: W. L. Woodward, Oct, 5, 2006.

Methods used: Please see attached project plan. Construction work was completed in the dry channel by sandbagging the brook at approximate Sta. 0+45 and pumping discharge below the existing roadway to the intertidal zone. The 4' high headwall at Sta. 0+5 was removed. Wing walls from Sta. 0+0 to 0+5 were removed and replaced. The headwall and two existing 18" RCMP at Sta. 0+0 were retained at the property owner's request. Both culverts are in fair condition, are 100% inundated at mean high tide and are not barriers to fish passage. By retaining the culverts and headwall, the existing road downstream of the project was kept in place.

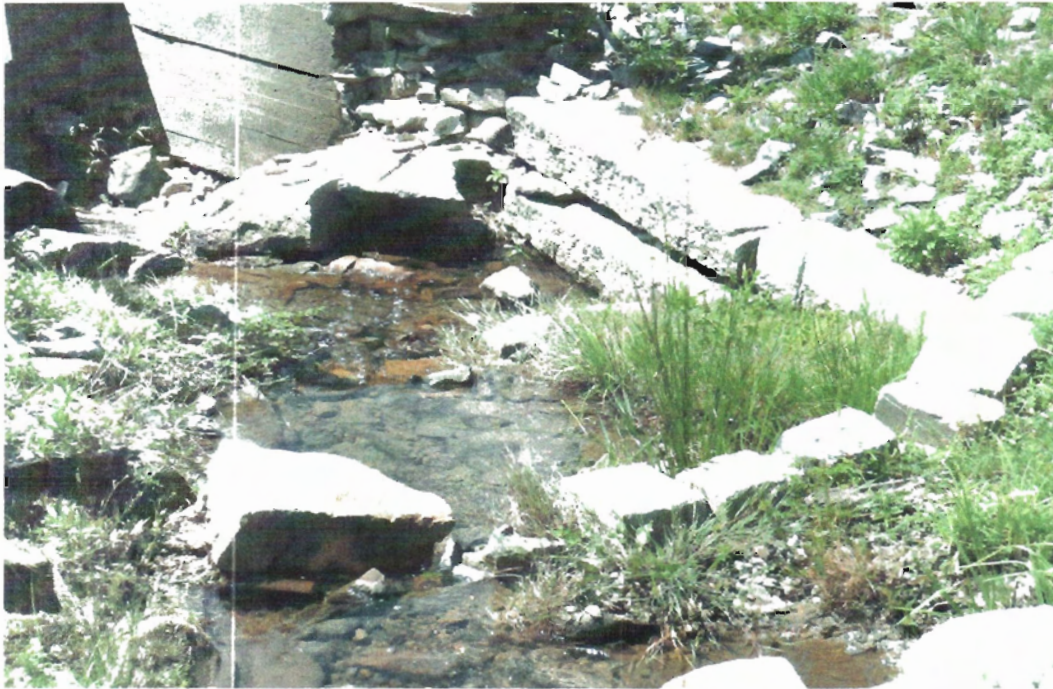
2011: View downstream from Sta. 0+10
Photograph: R. Van Riper, July 2011

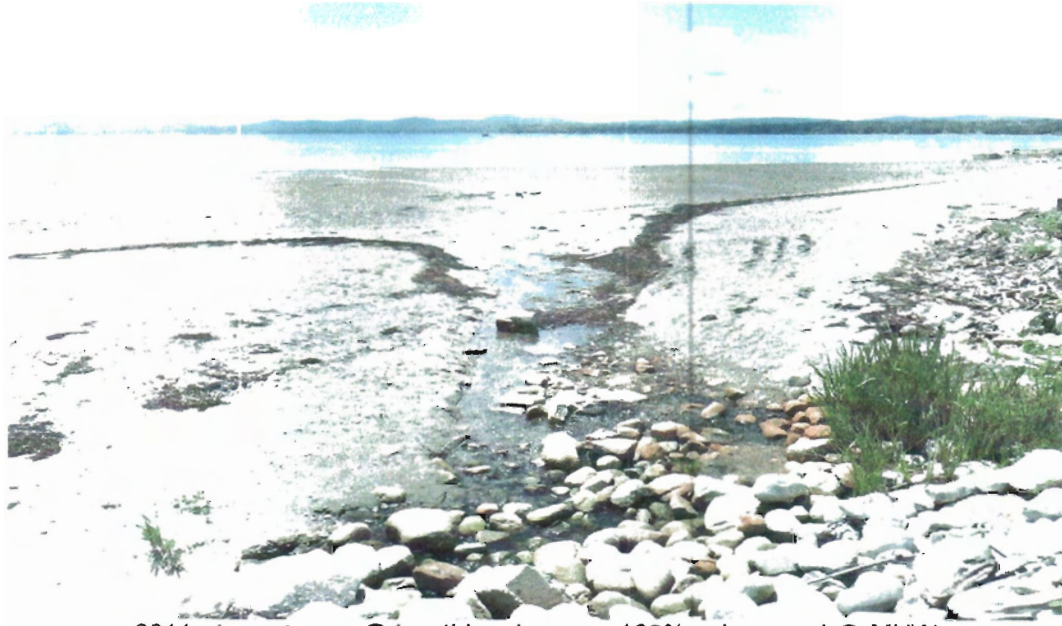
2011: downstream @ low tide, pipes are 100% submerged @ MHW
Photograph: R. Van Riper, July 2011
