## Eastern Brook Trout Joint Venture Completed Project Report Form

**Project Title:** Restoring Stream Connectivity in the WB Machias River, ME. EBTJV/NFHAP-USFWS FONs 53371-2009-350

• Location: T36MD BPP Washington County, Maine

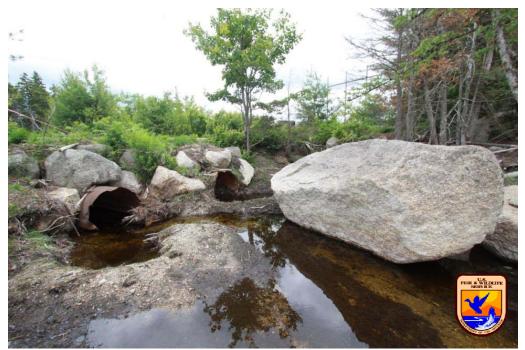
Looking downstream to old culverts at the outlet stream to Knox Lake (n=2 culverts).

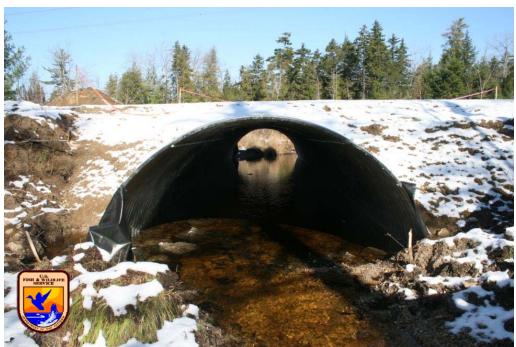
Looking Downstream to the new 12 ft wide Open Arch on Knox Lake Outlet Stream . Oct 31, 2011

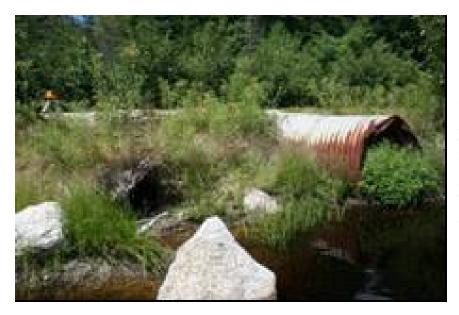
Before: 39:30:0 logging road. Looking downstream to inlet

Notice large impoundment above the road. Culverts blocked with debris.

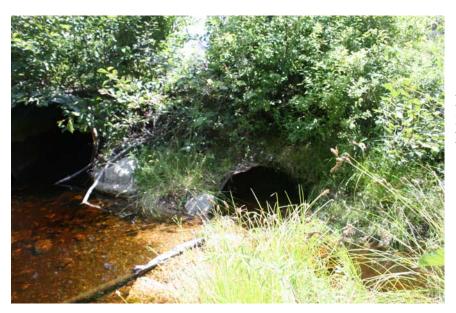
Before: 39:30:0 logging road. Looking upstream to outlet

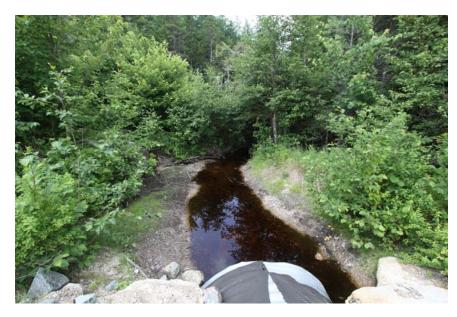
After: 39:30:0 logging road. Looking downstream from outlet.

Beaver had built a small dam below the road- in the tree's.

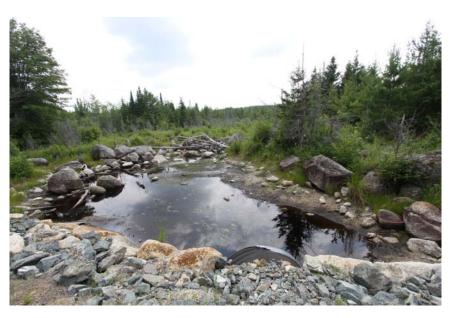
After: 39:30:0 logging road. Looking upstream from inlet.

Rocks were covered by water before project!
