INTERIM FINANCIAL AND PERFORMANCE REPORT

JAM BLACK BROOK CULVERT REPLACEMENT

Searsmont, ME-EBTJV-NFHAP

USFWS FONs Project Number 53371-2010-361

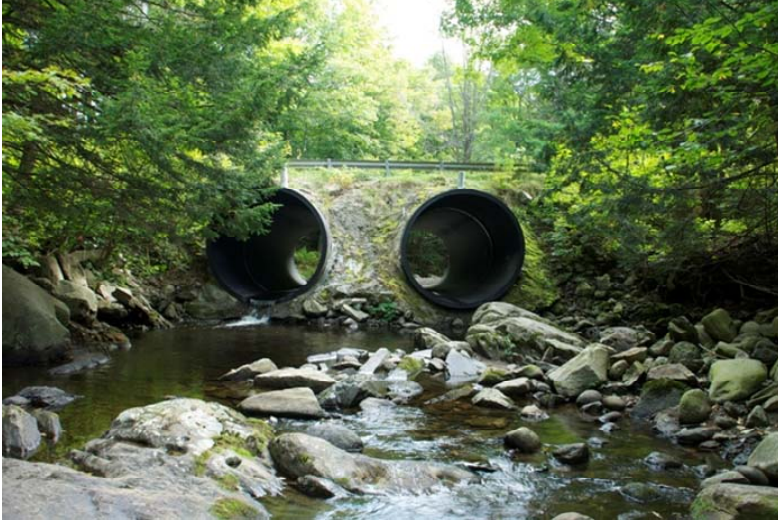
From Downstream

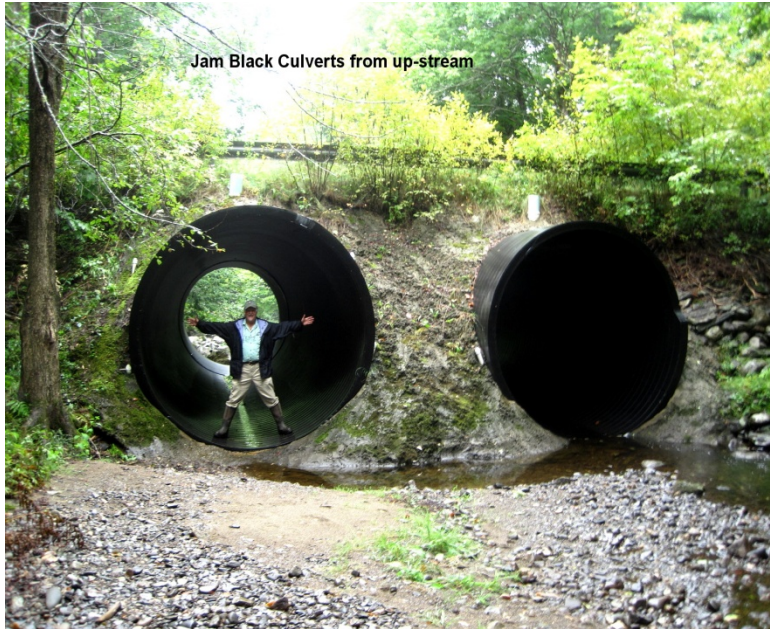
sediment above culverts.)

From Upstream (Note accumulated

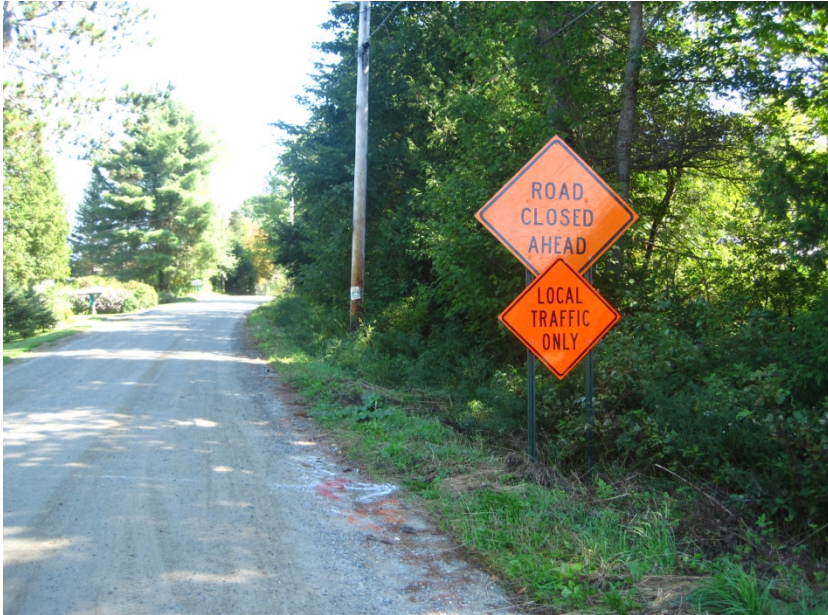
Signage Installed

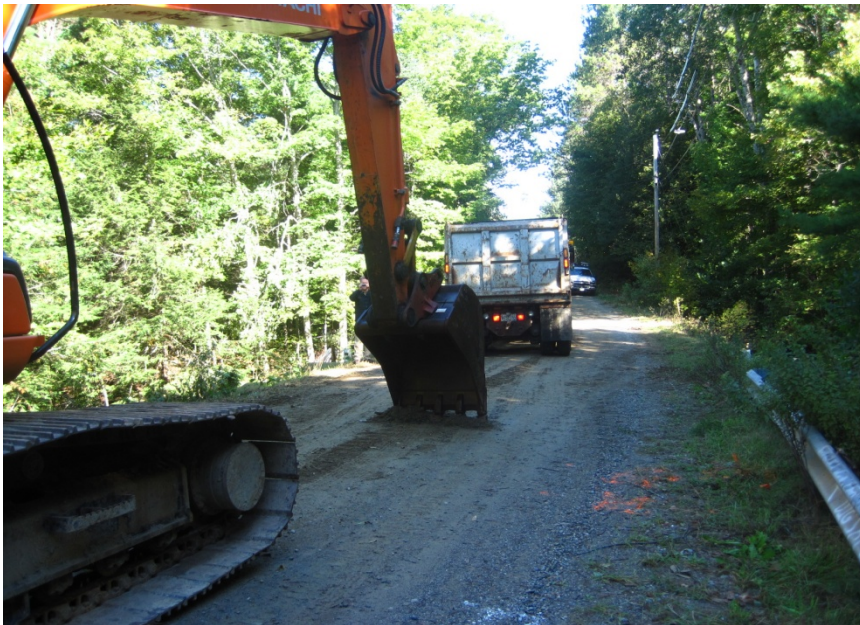
Beginning of Excavation

- Because a significant amount of bedrock was discovered within the excavation zone, the location of the structure was shifted approximately 6 feet to the north. No other dimensions of the structure were changed. The presence of bedrock also required a minor adjustment to the project budget to cover costs of rock removal, and resulted in the need for two permit amendments to grant extensions of the in-water time of work window. Ultimately, the in-water work window was extended to October 17, and in-water work was completed on October 16.

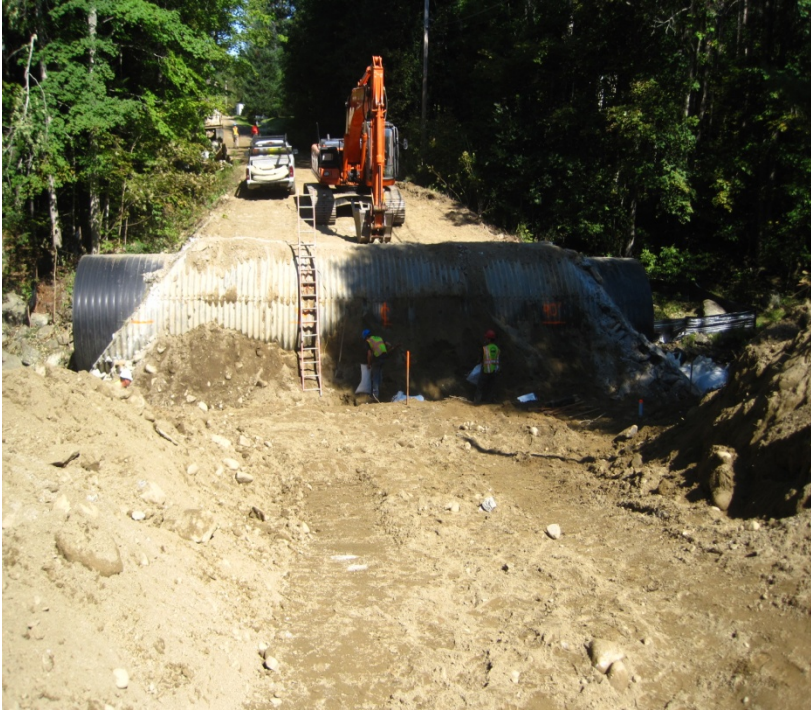
First pipe exposed.

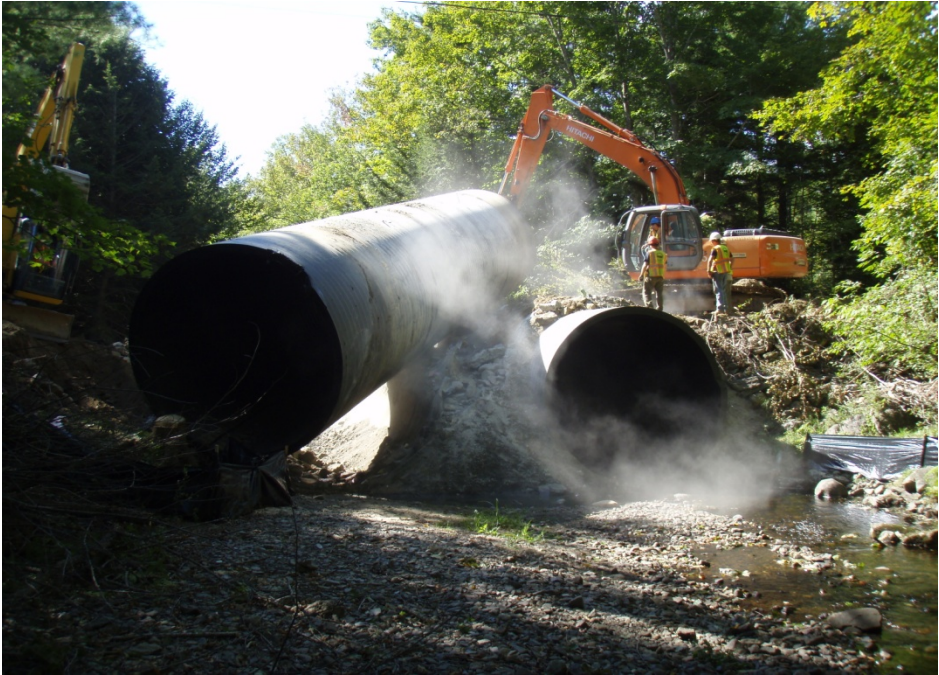
First pipe removed.

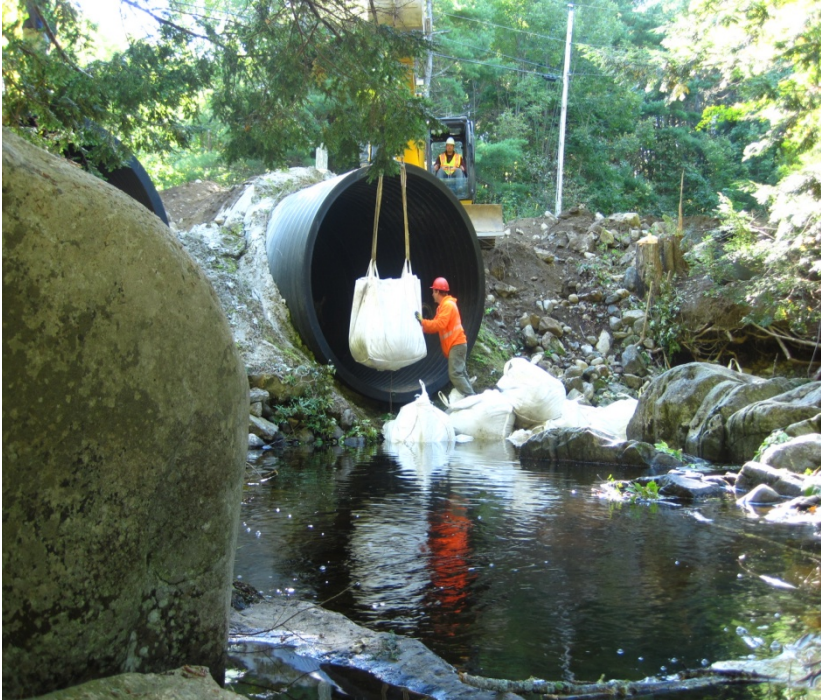
Sandbag Installation

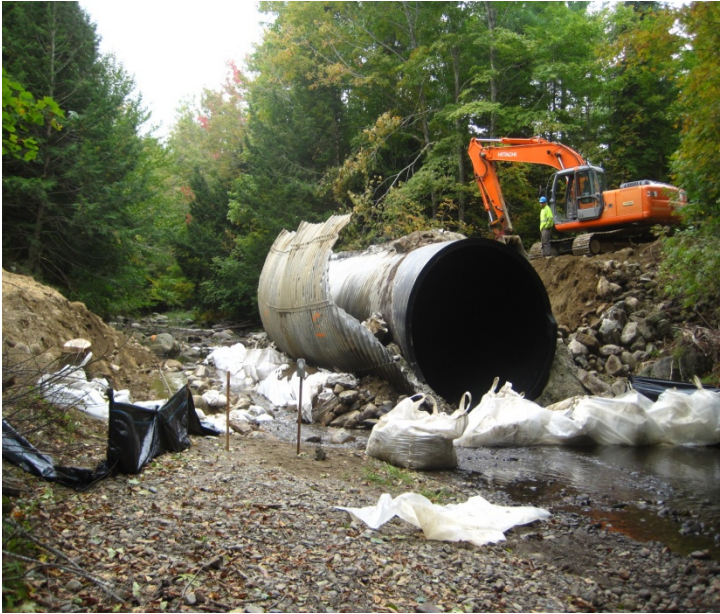
Water Passed Around Second Pipe.

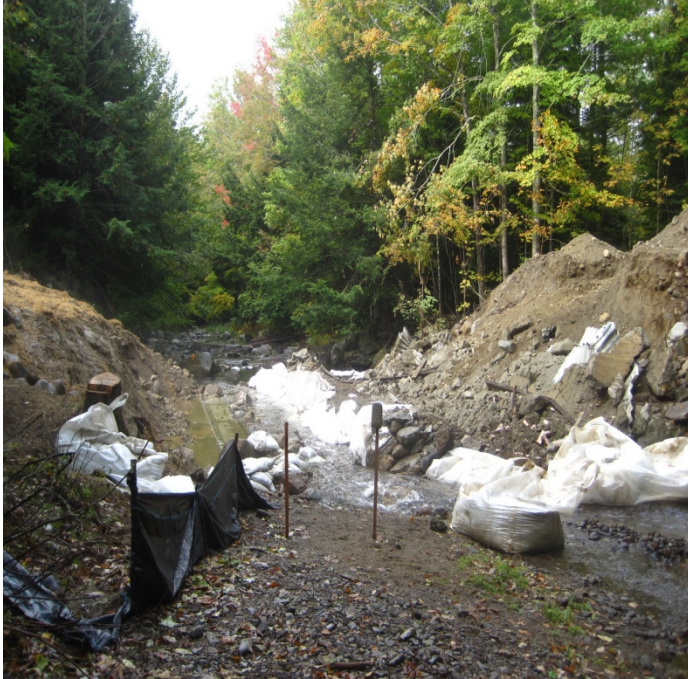
Both Pipes Removed—Note footer

installation on left.

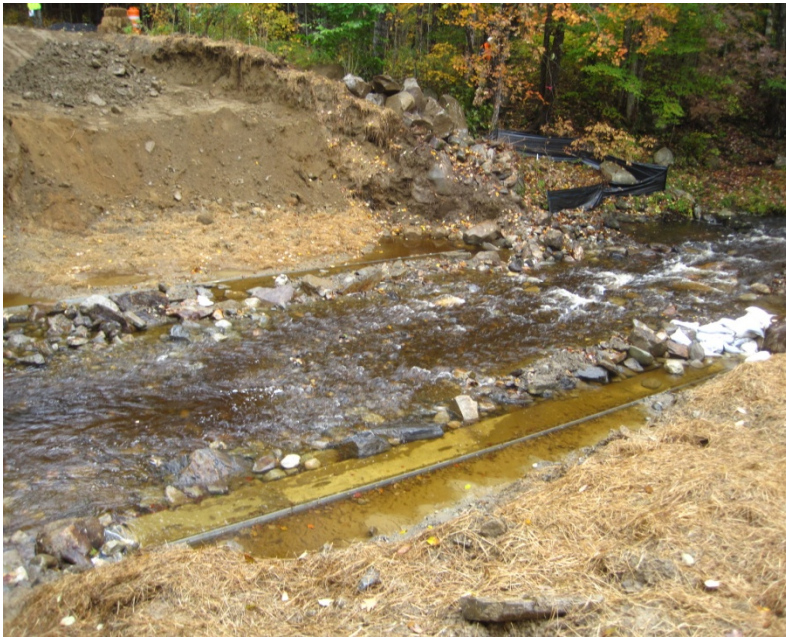
Both Footers Installed.

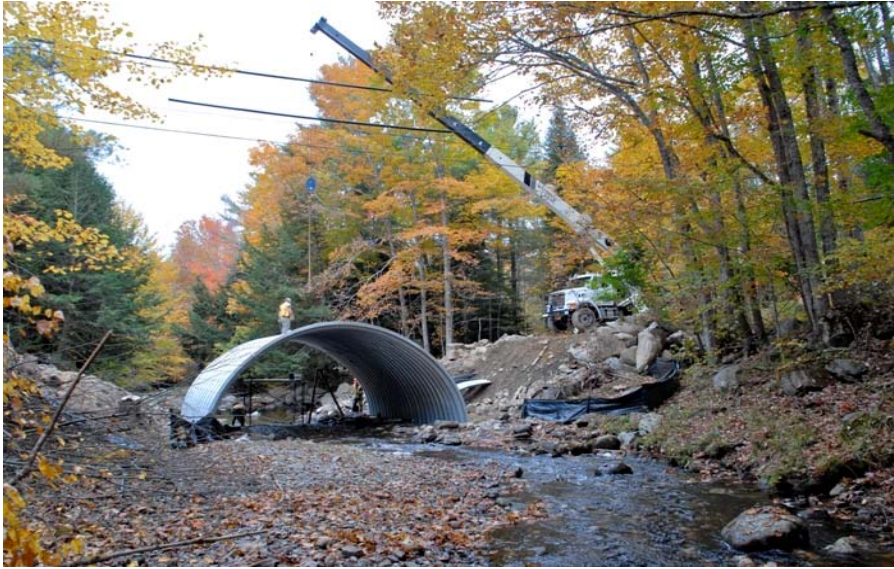
Placement of First Section

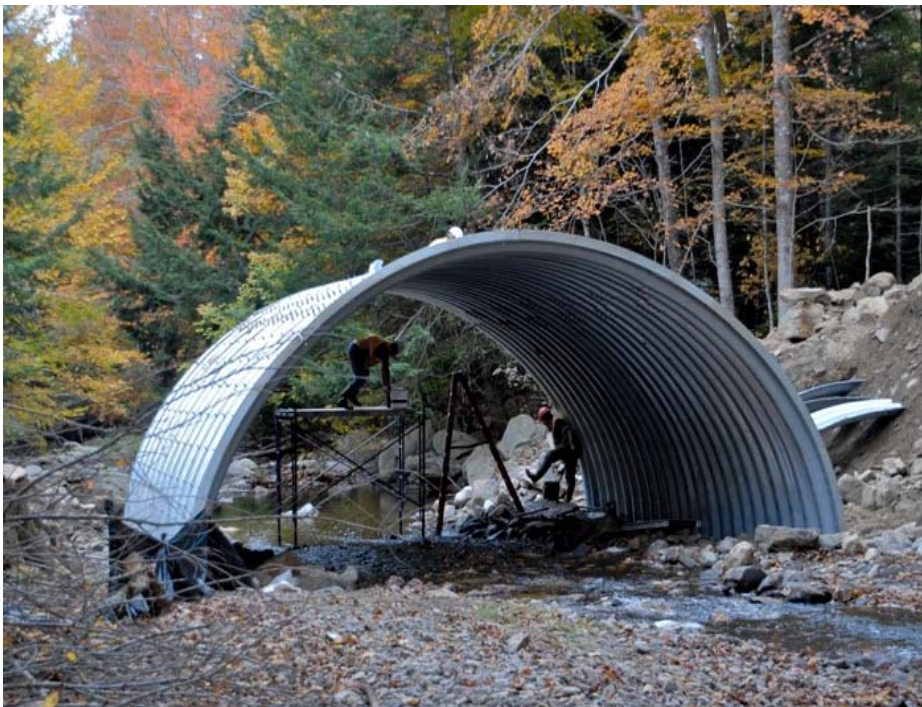
Assembly

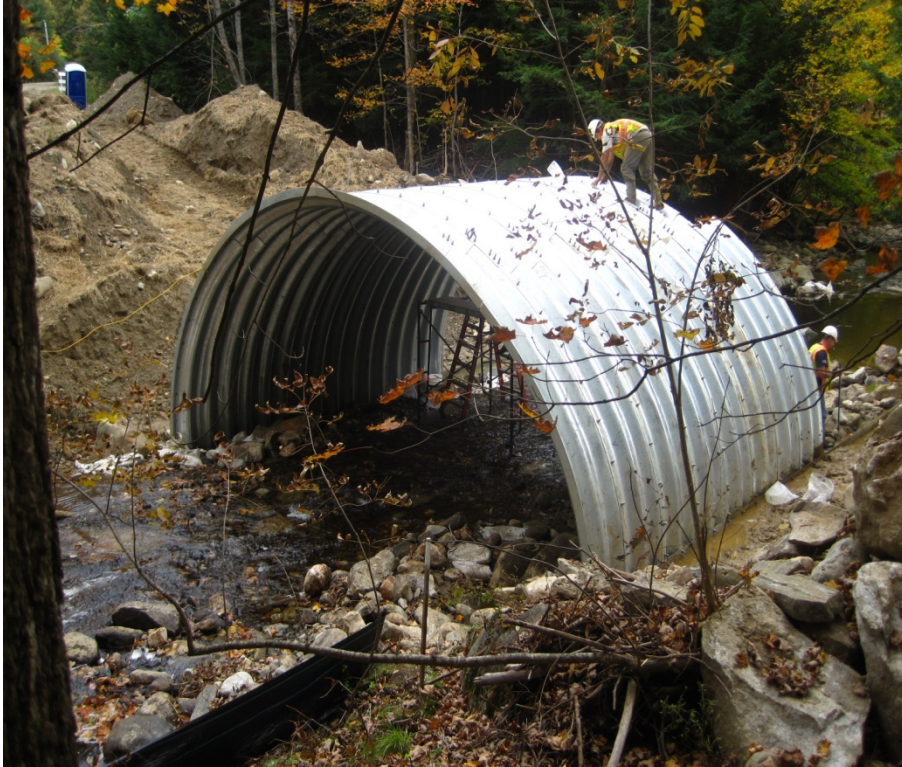
Assembly

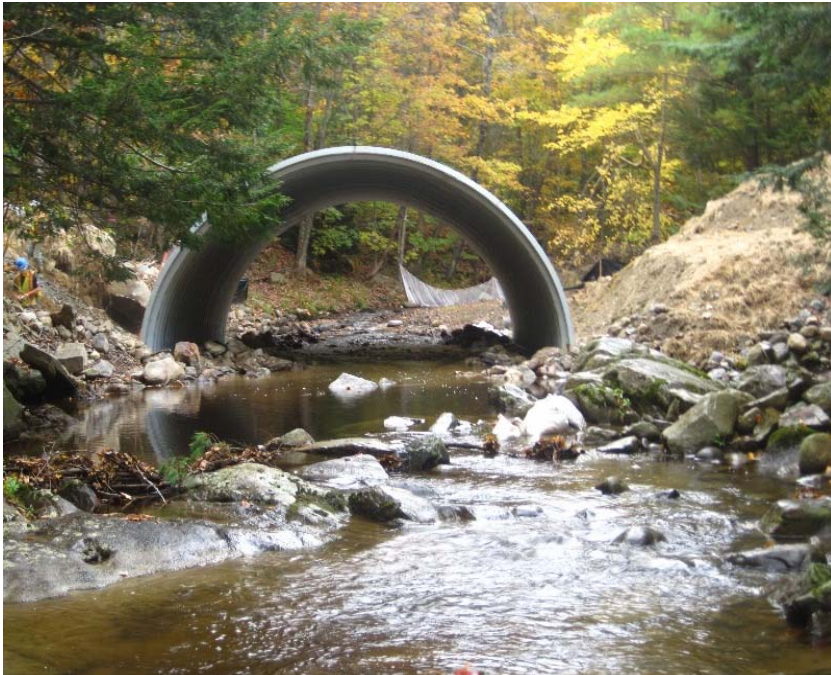
Assembly Complete

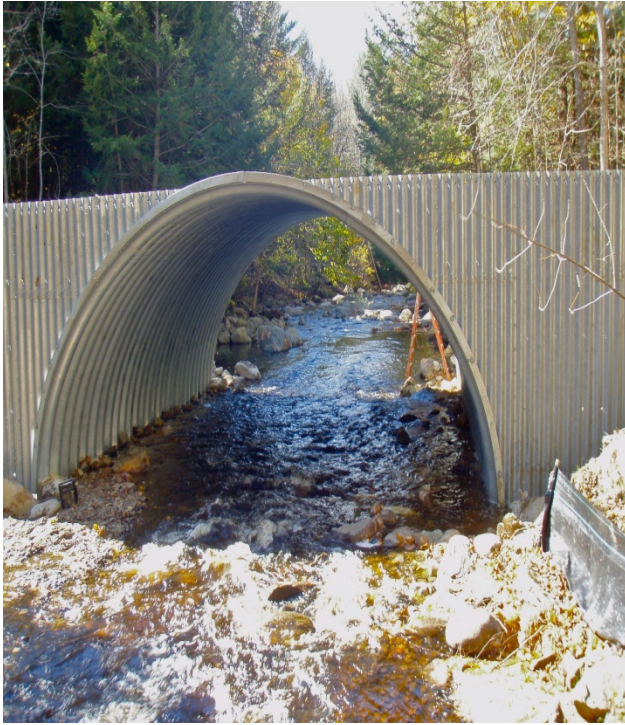
Downstream Headwall

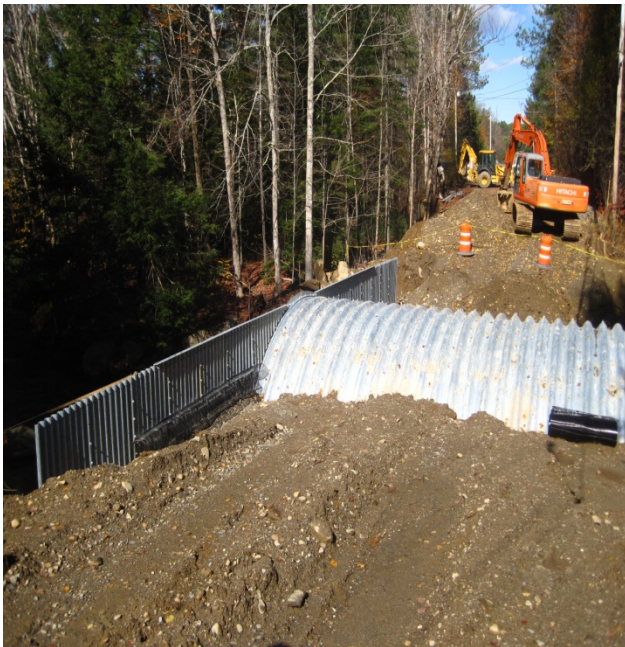
Headwalls Complete—Fill Placement

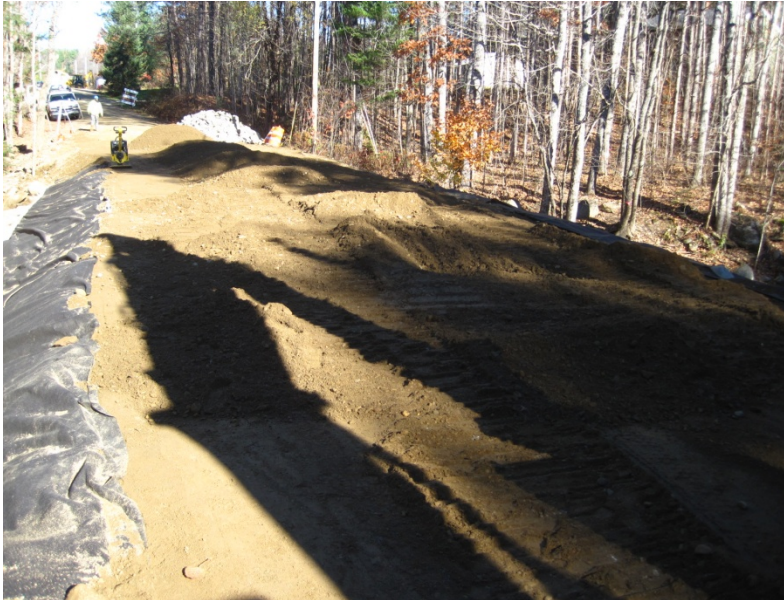
Fill Placement

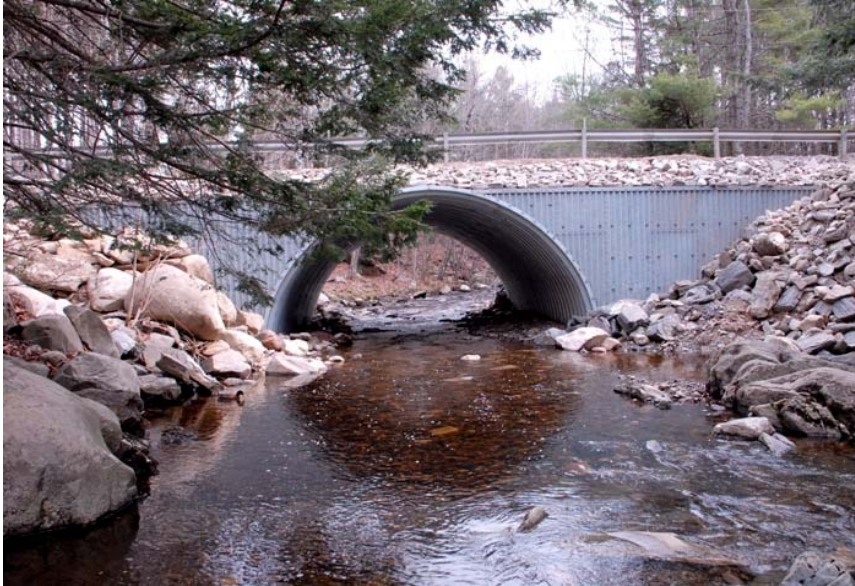
From Downstream

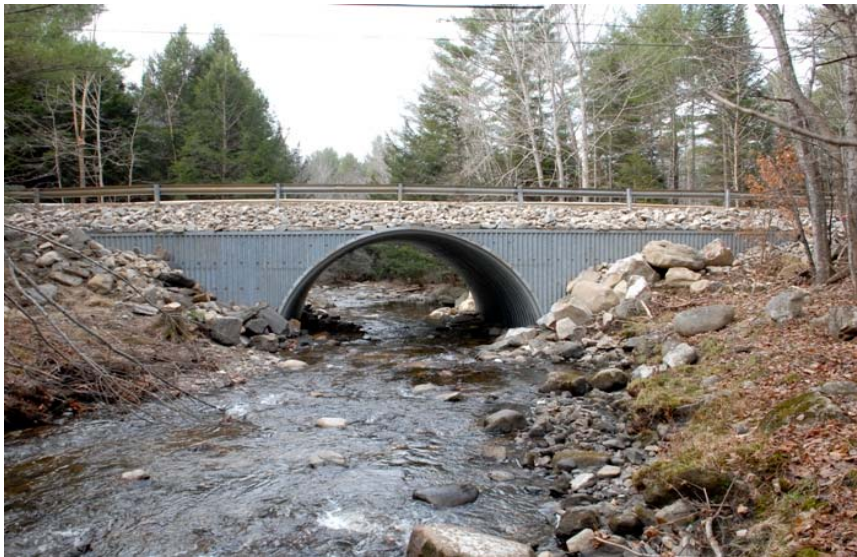
From Upstream (Note lack of accumulated sediment above structure.)

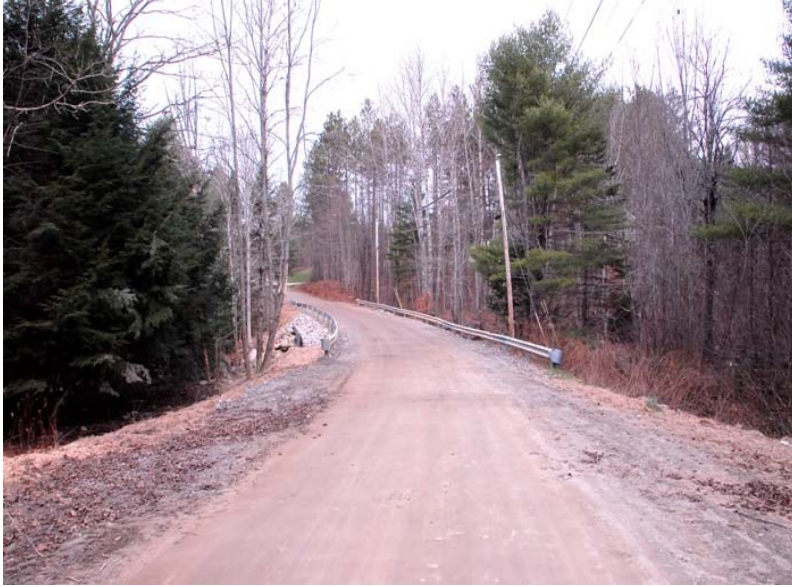
Restored Road

- Because work was not completed until the end of October there was concern that seed placed on disturbed areas would not have sufficient time to sprout before freeze up. As a result, disturbed areas were mulched but not seeded, and the contractor will return to the site next spring to complete seeding according to NRCS specifications for the project. There may also be a need for some minor repairs to the road surface, primarily road grading. These will occur, if necessary, after the ground thaws in the spring.

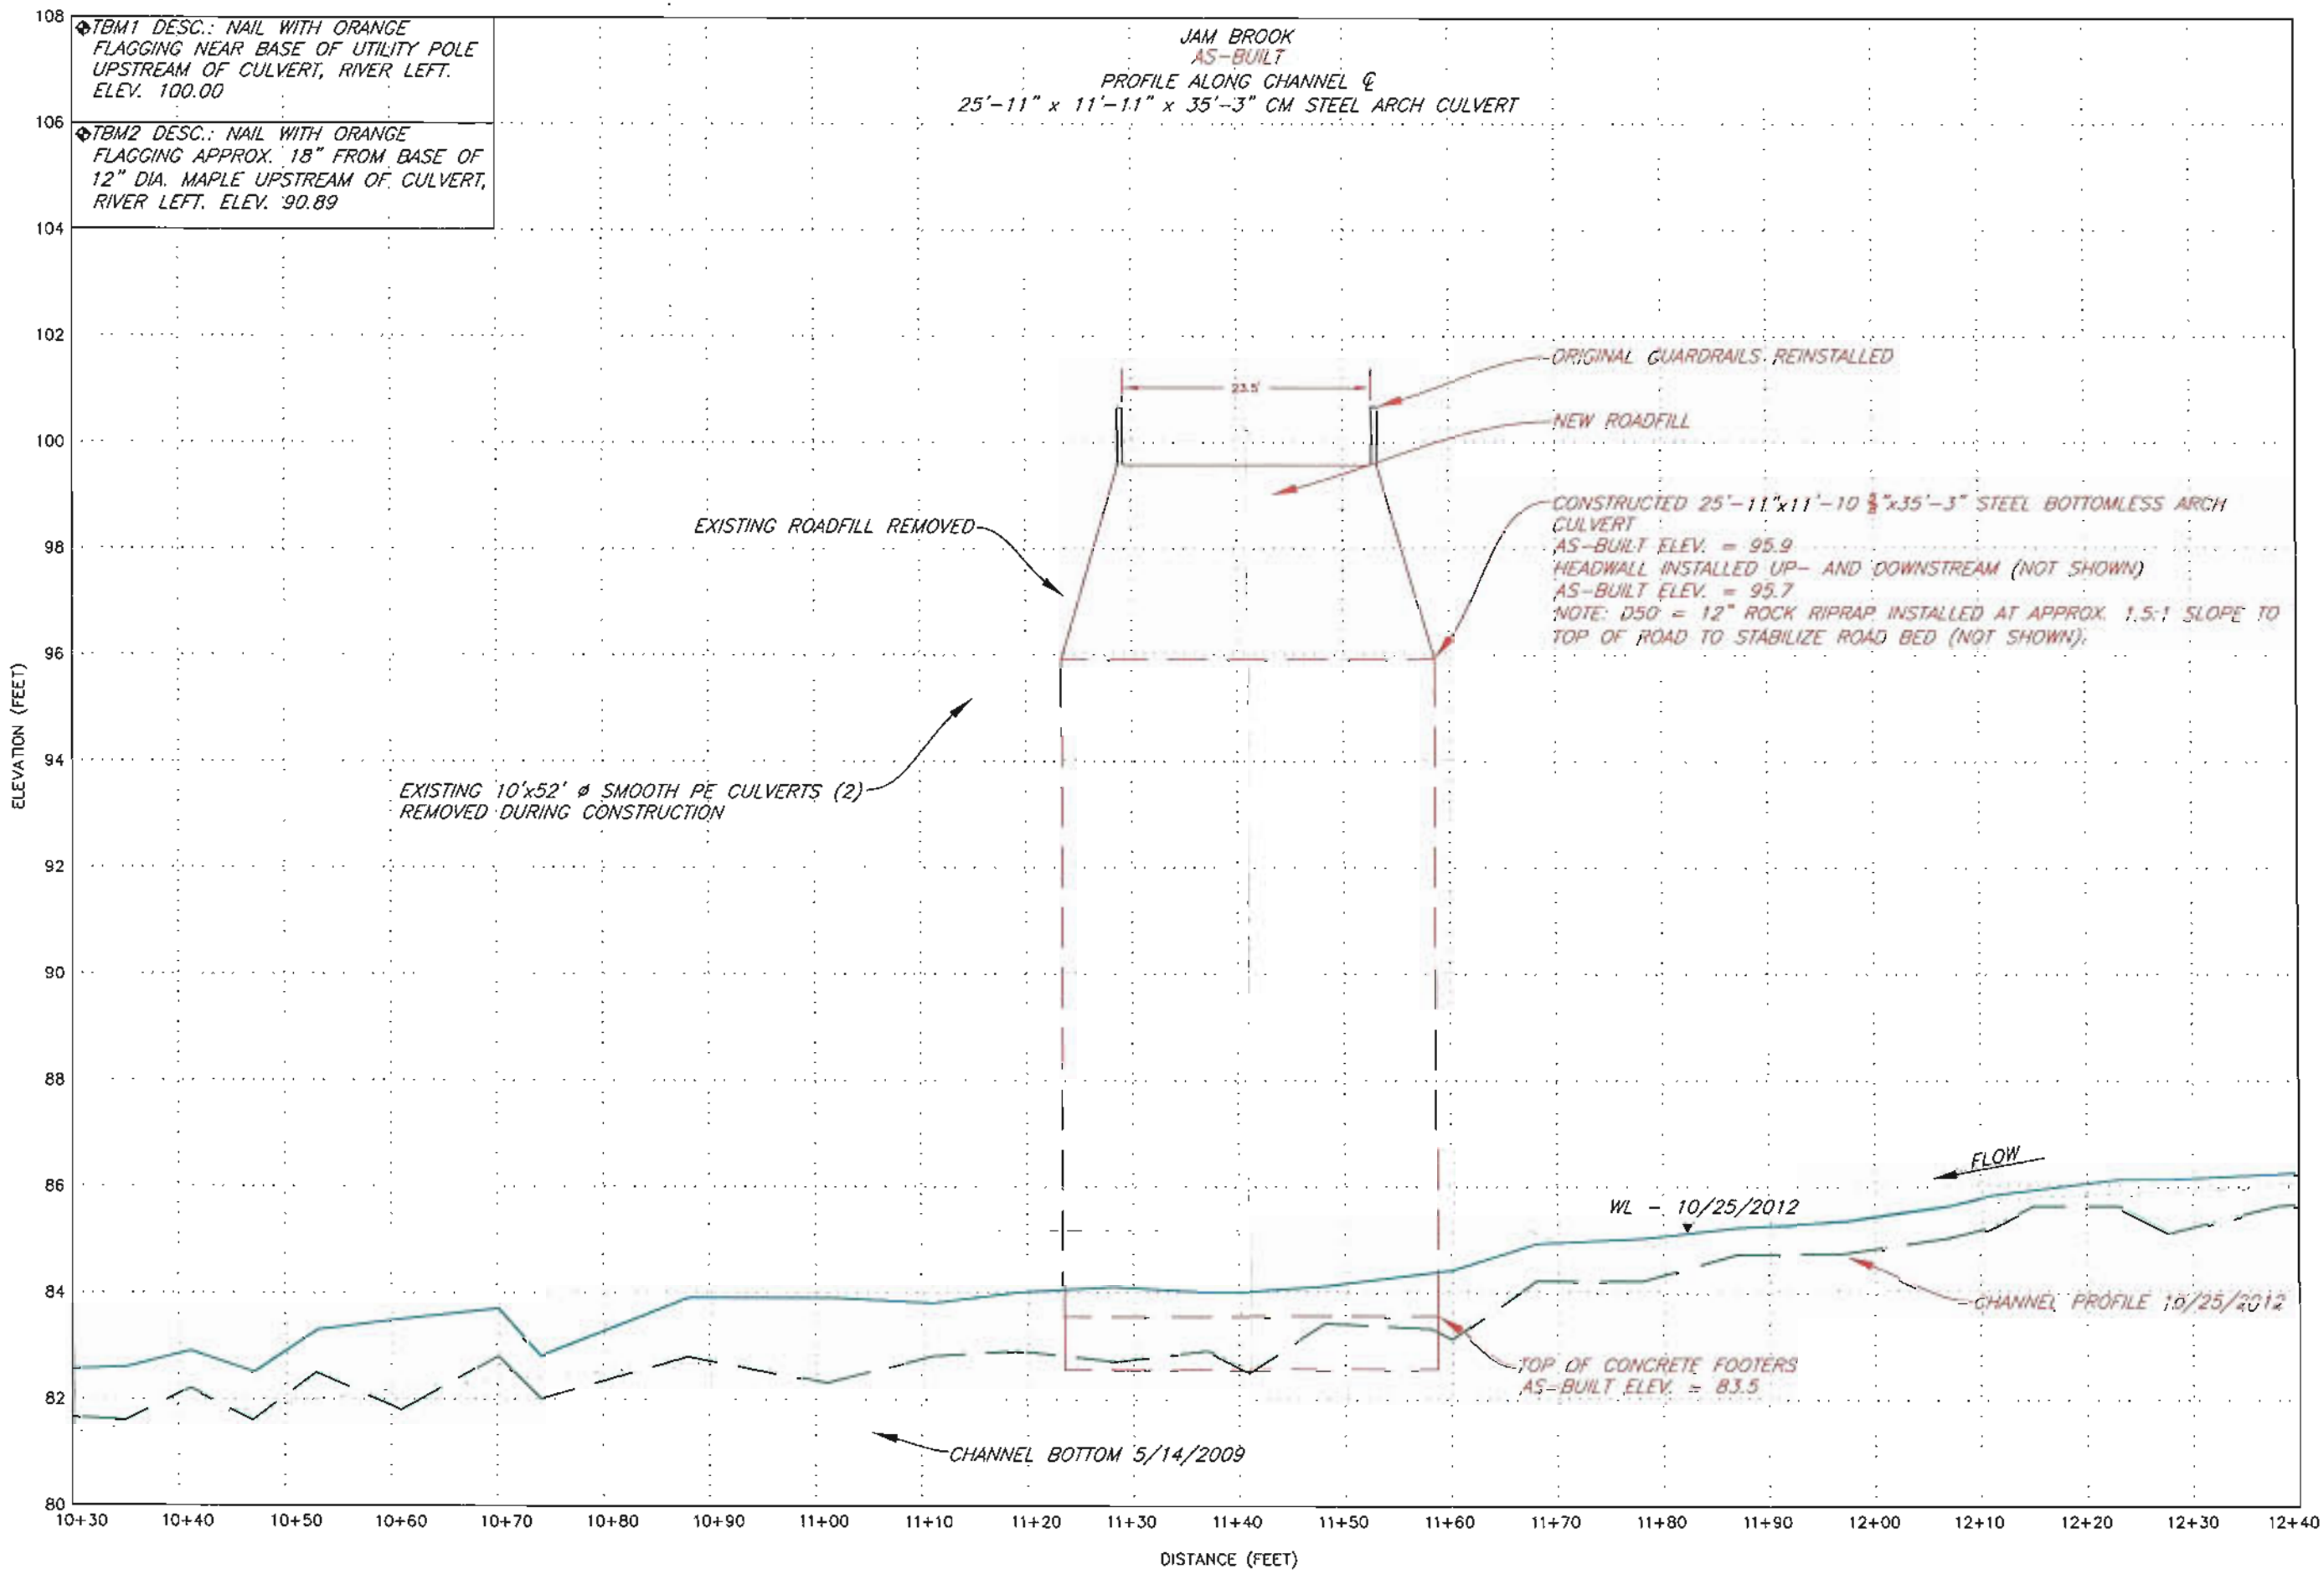
TROUT UNLIMITED - JAM BROOK
 AS-BUILT

Page 1: Pre- and Post-Construction Longitudinal Profile of stream reaches upstream and downstream of structure.

- Pre- and post-construction longitudinal profiles and channel cross sections. Pre- and Post-construction longitudinal profiles are attached, along with as-built drawings of the replacement structure. Pre-construction cross sections were collected, and post construction cross sections will be collected this spring after spring high water. TU will provide those when post-construction cross sections have been completed.

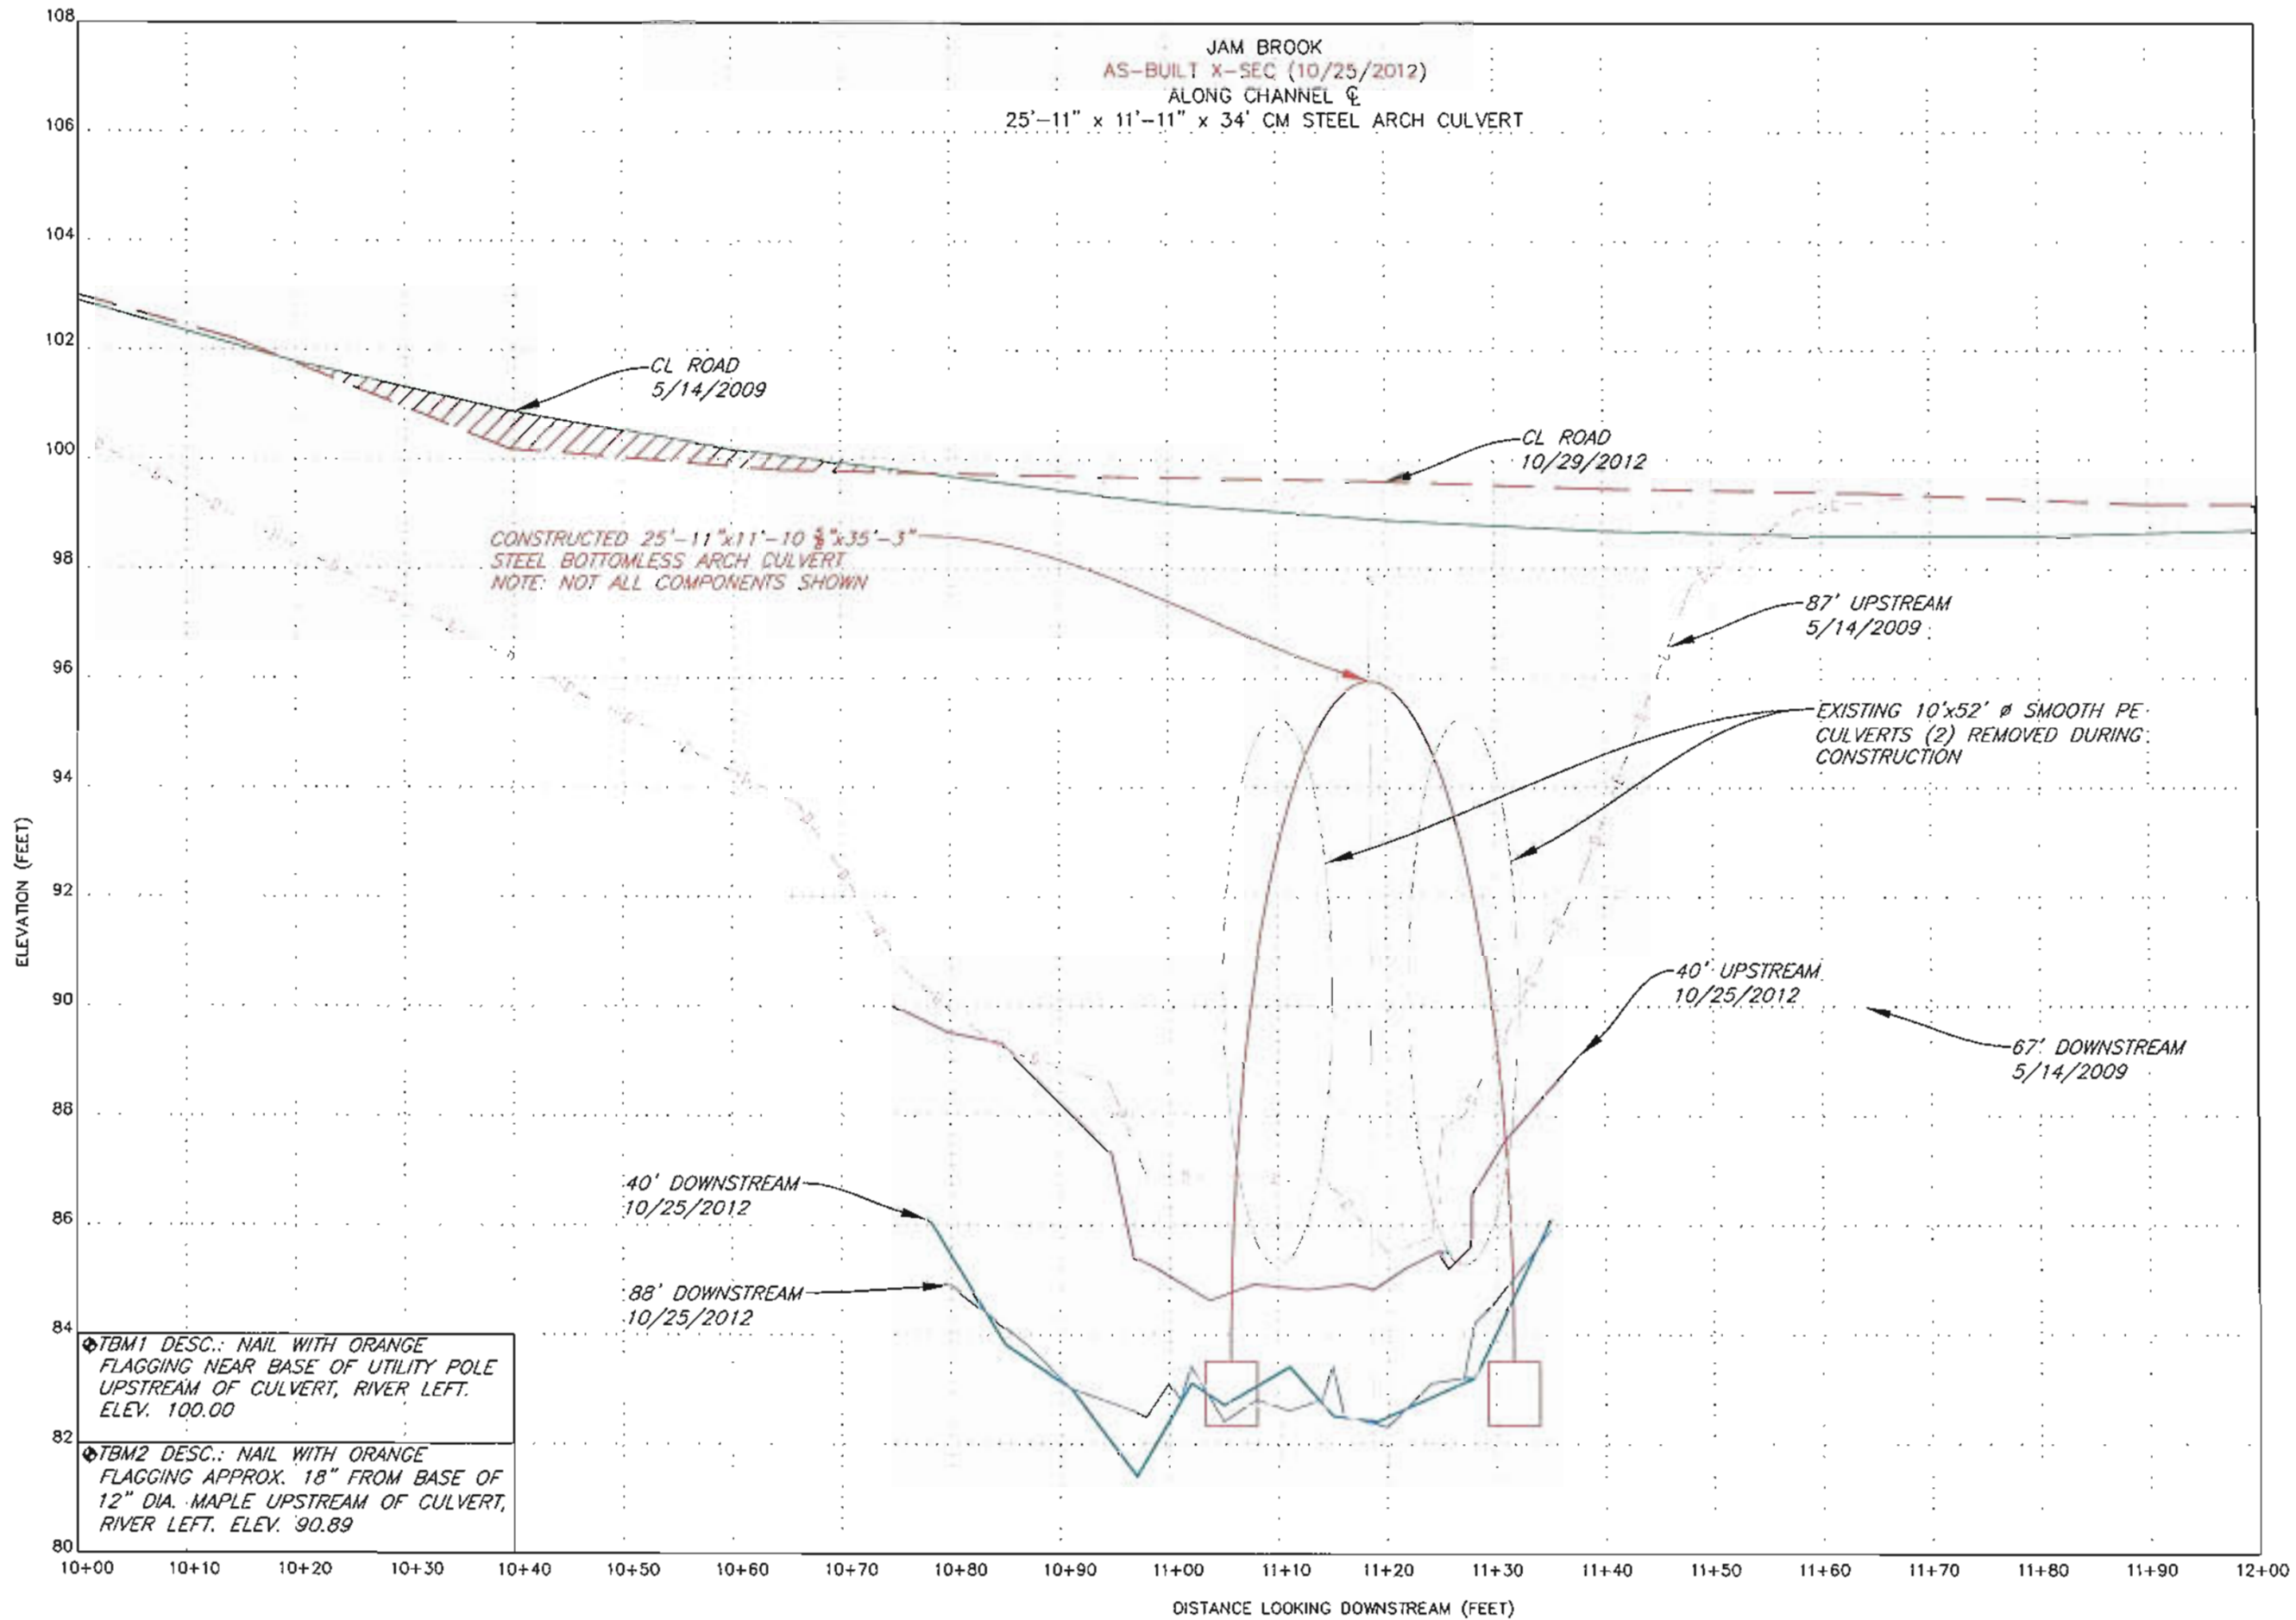
TROUT UNLIMITED - JAM BROOK
AS-BUILT

Page 3: Pre- and Post-Construction monitoring cross sections
