Connecticut River Aquatic Habitat Connectivity

Fish Passage in the White River Watershed

Marsh Brook on Marsh Brook Rd Road, Rochester Vermont

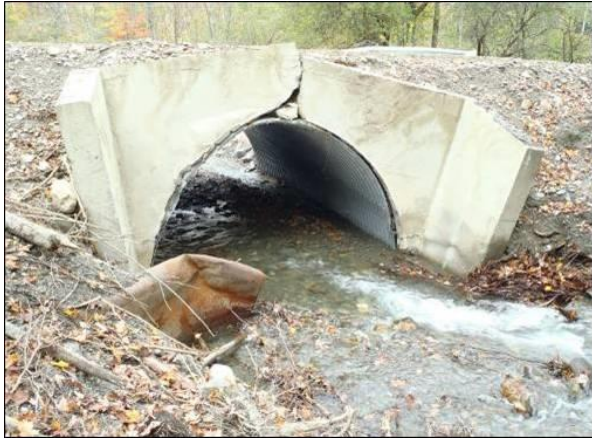
Before

Left: A view of the Marsh Brook culvert outlet on Marsh Brook road showing the undersized culverts with minimal fish or aquatic organism passage. **Right:** New Marsh Brook culvert at the Marsh Brook road crossing designed for fish and aquatic organism passage as well as flood resiliency.

Problems / history: Multiple culverts in Rochester Vermont were in need of emergency repair following the flooding from tropical storm Irene in August of 2011. Following tropical storm Irene many of the emergency fixes were designed to quickly open roads for vehicle traffic, but not always allow for fish and aquatic organism passage. Working closely with FEMA and the town of Rochester the US Fish and Wildlife Service has provided technical assistance, engineering designs, and project over site to ensure projects allow both fish and aquatic organism passage.

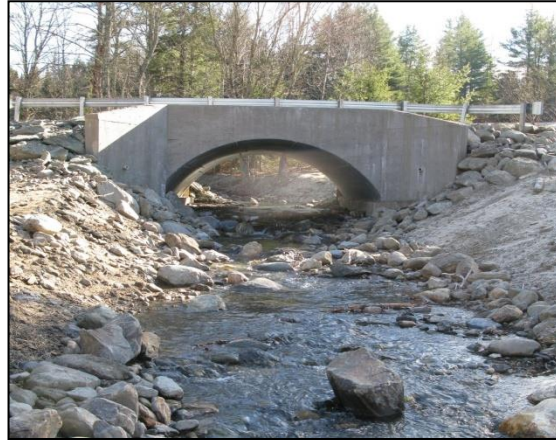
After

Site description: Marsh Brook in Rochester Vermont is a headwater tributary to the White River and supports a thriving fishery including Atlantic salmon and a wild brook trout population. In combination with the repairs to another road crossing structure downstream on Marsh Brook, this new culvert will allow native brook trout to access over 2.5 miles of critical thermal refugia and spawning habitat.
