Project Title: Mill Creek (Tygart River), WV: Large Woody Material Strategic
“Chop and Drop”

MILL CREEK, WEST VIRGINIA
EASTERN BROOK TROUT JOINT VENTURE PROJECT
FINAL REPORT

***Aquatic Habitat Program
Eastern Brook Trout Joint Venture Project Final Report
Mill Creek (Tygart River), WV: Large Woody Material Strategic “Chop and Drop”
March 25, 2016***

Project Location: Kumbrabow State Forest (Randolph County), WV

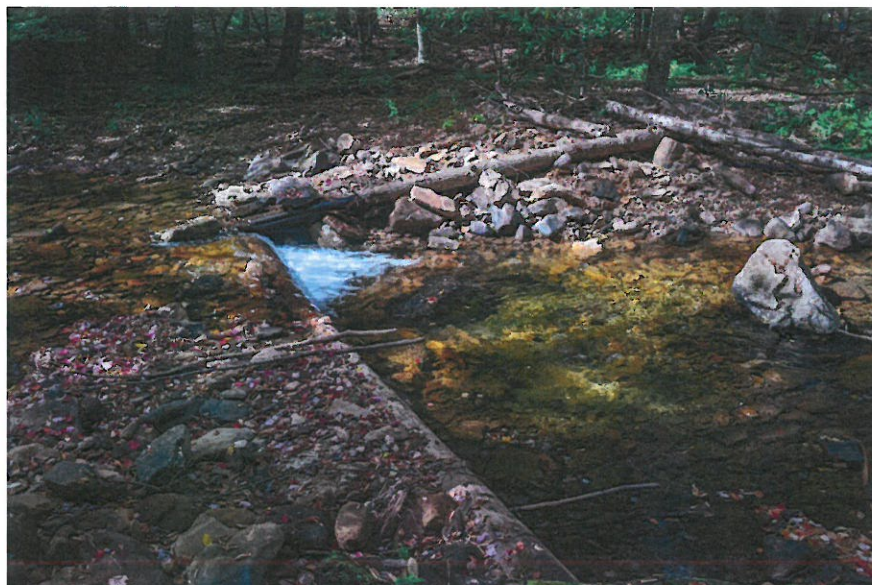
At Low Flow

Log cross-vanes (to promote channel narrowing and pool scour)

- Many single log vanes had been very vulnerable due to inadequate entrenching of in-stream tips; depth to bedrock was often the reason
- Log cross-vanes had also been vulnerable, again due to inadequate entrenching and/or installation in reaches with extreme bank-full widths; again depth to bedrock was frequently an issue

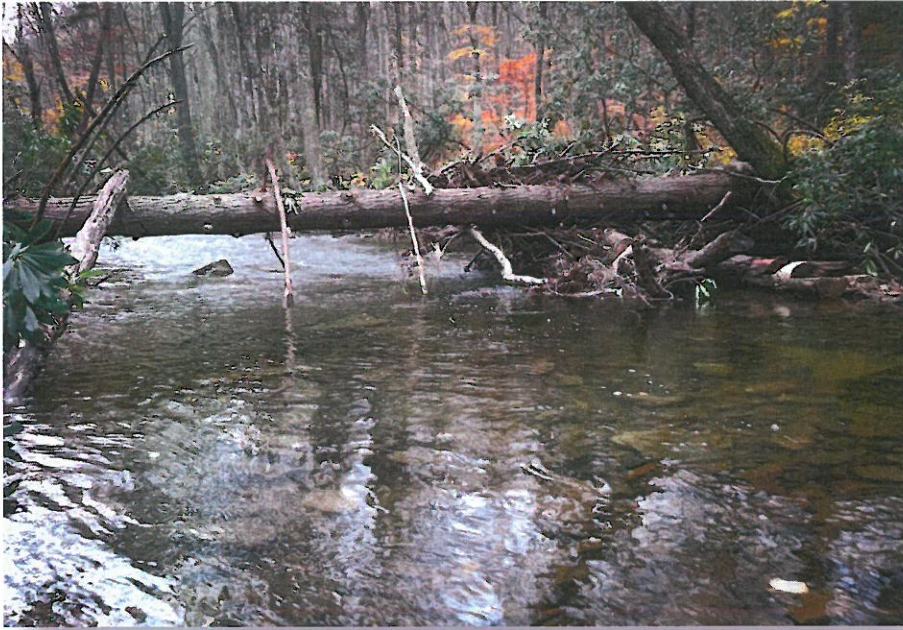
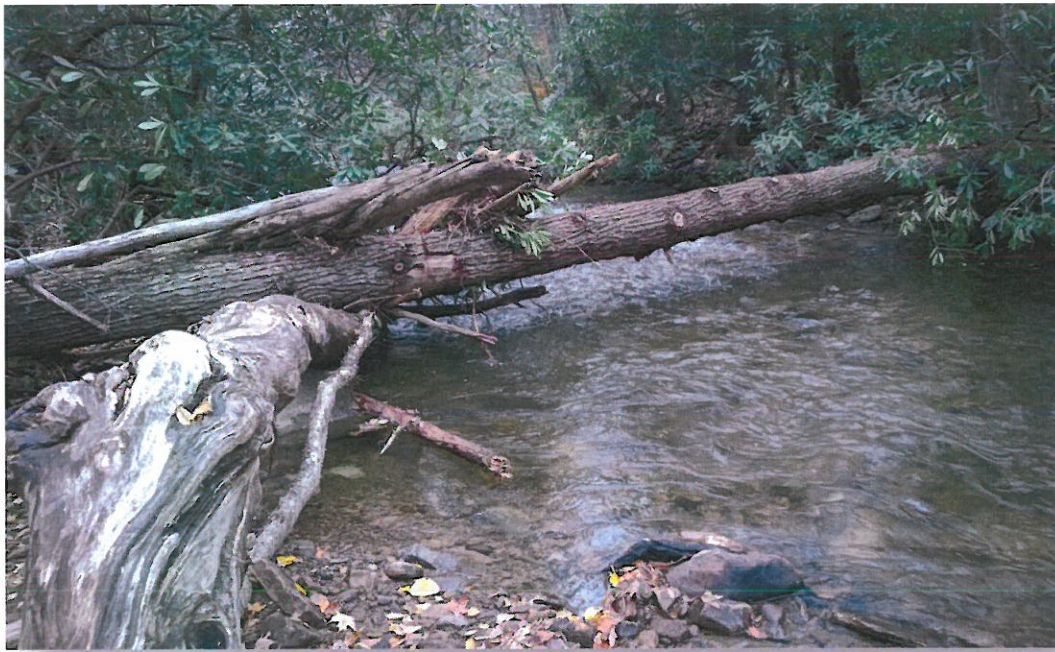
Elevated cross-channel “digger” logs (to promote pool scour and recruitment of mobile wood at the margins)

- Cross-channel digger logs failed where the ends of the logs had been insufficiently entrenched or secured
- Virtually all toe wood/mud sill structures had survived

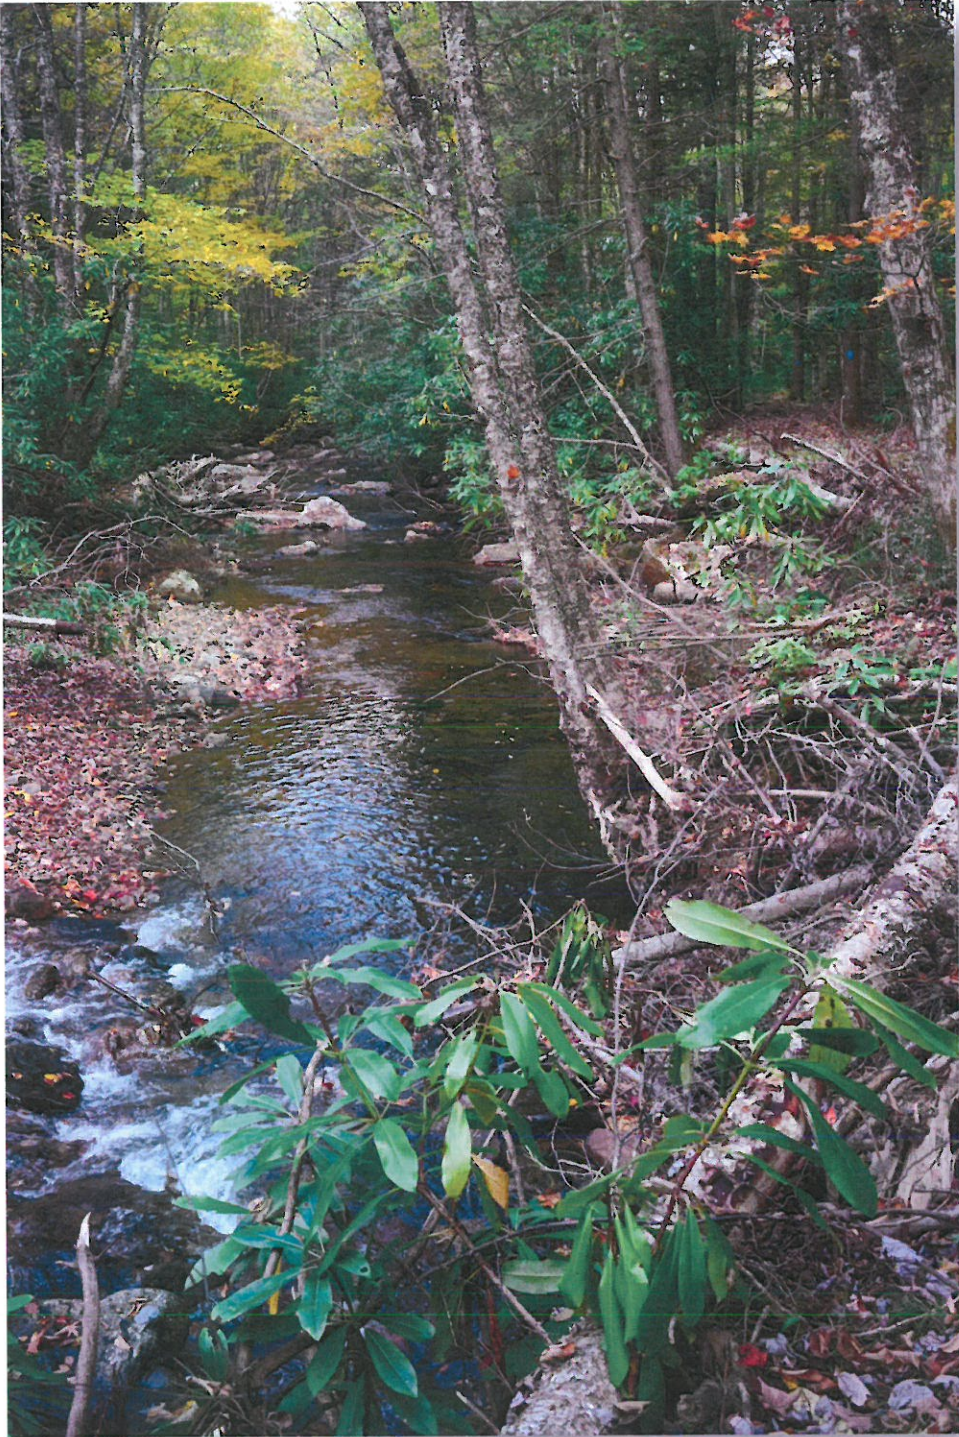
Toe wood/mud sills (to provide depth with overhead cover at stream margins and develop benches to control bank erosion)

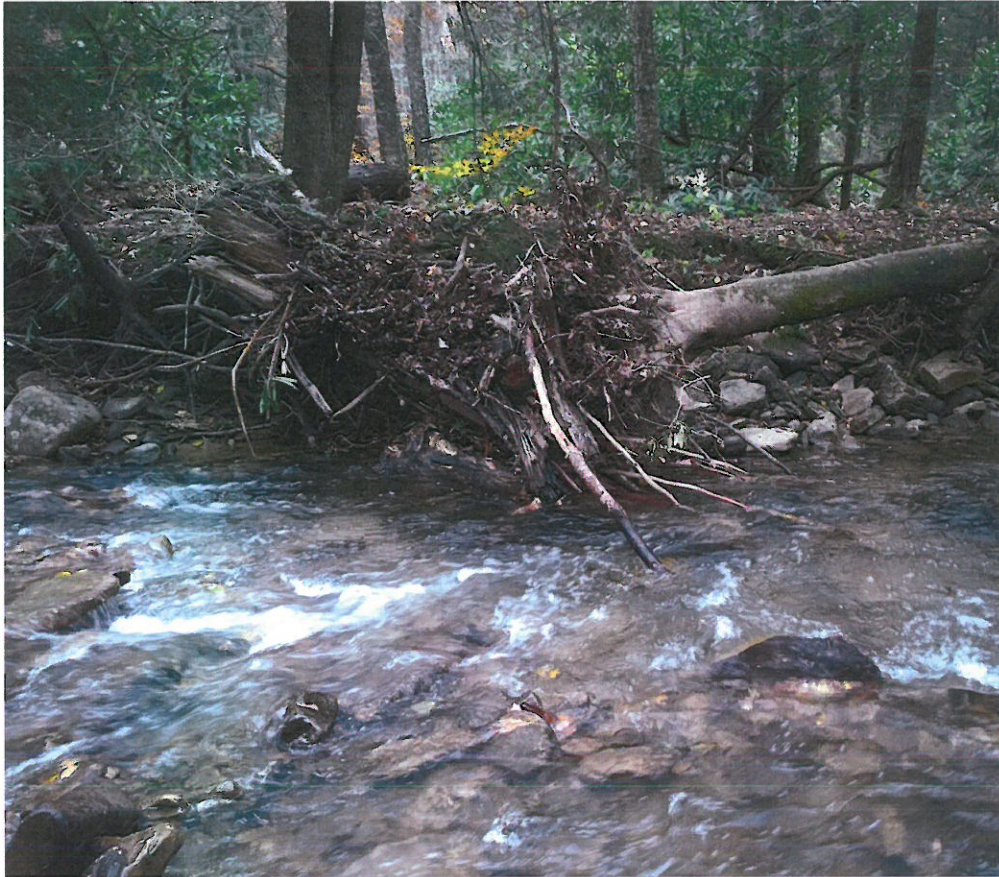
Rootwads (to promote channel scour)

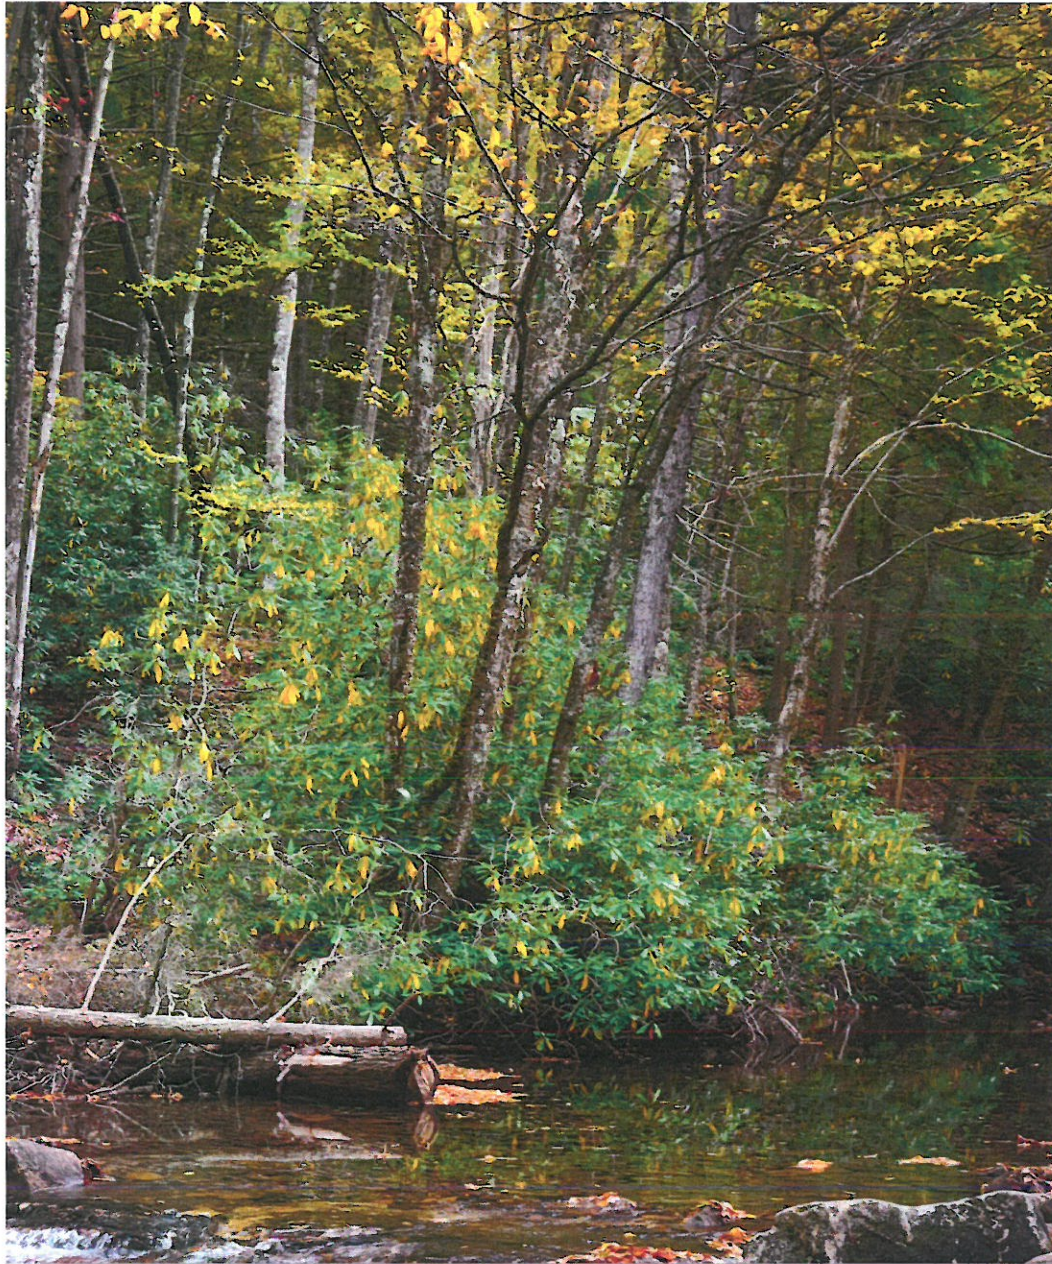
Log deflector structures (to redirect flows)

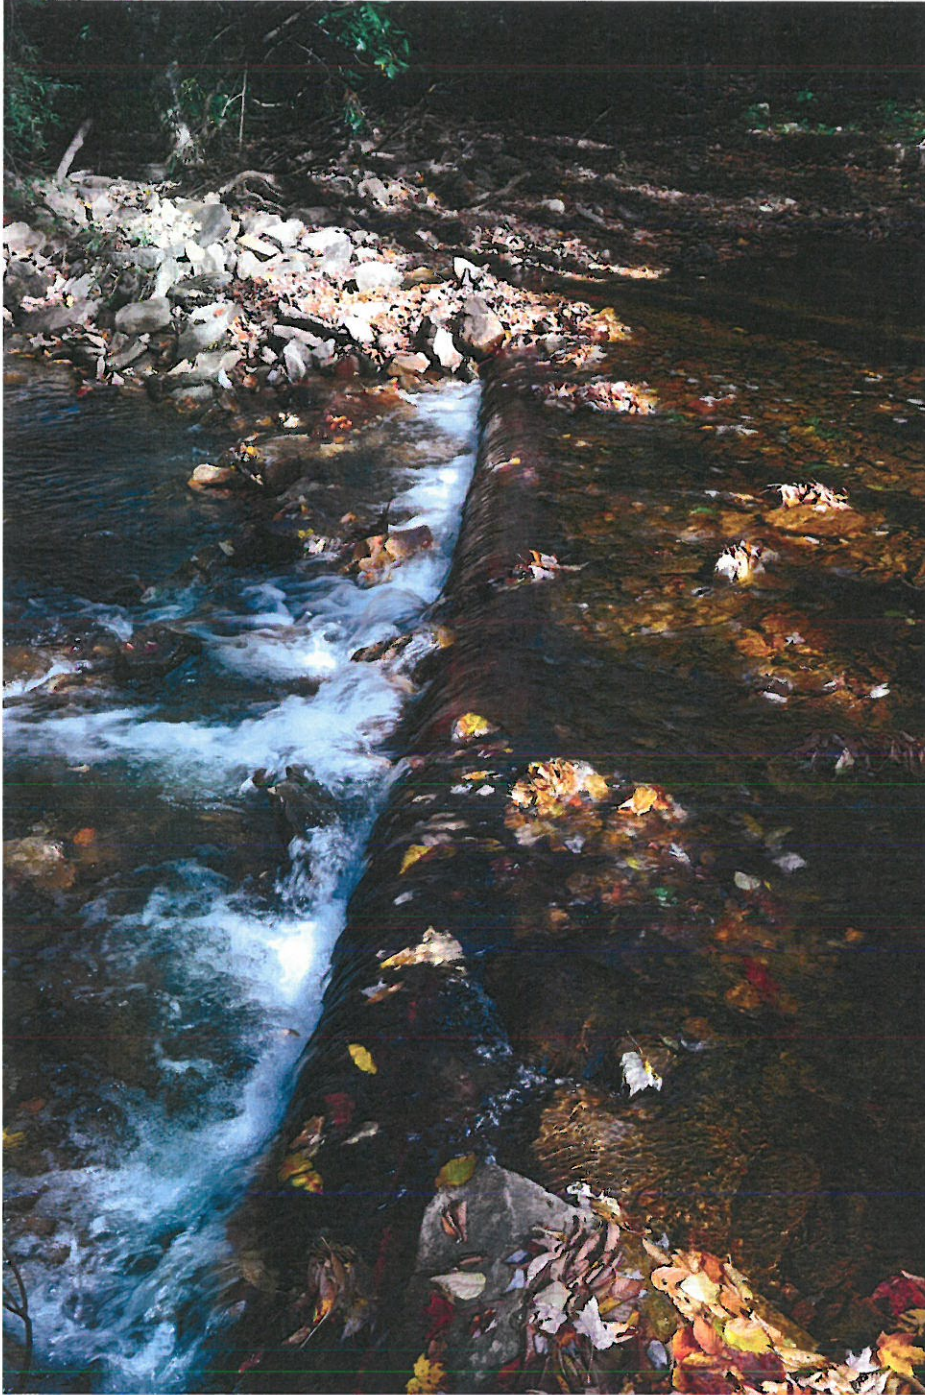
Cross-channel grade control structures (to retain fords)

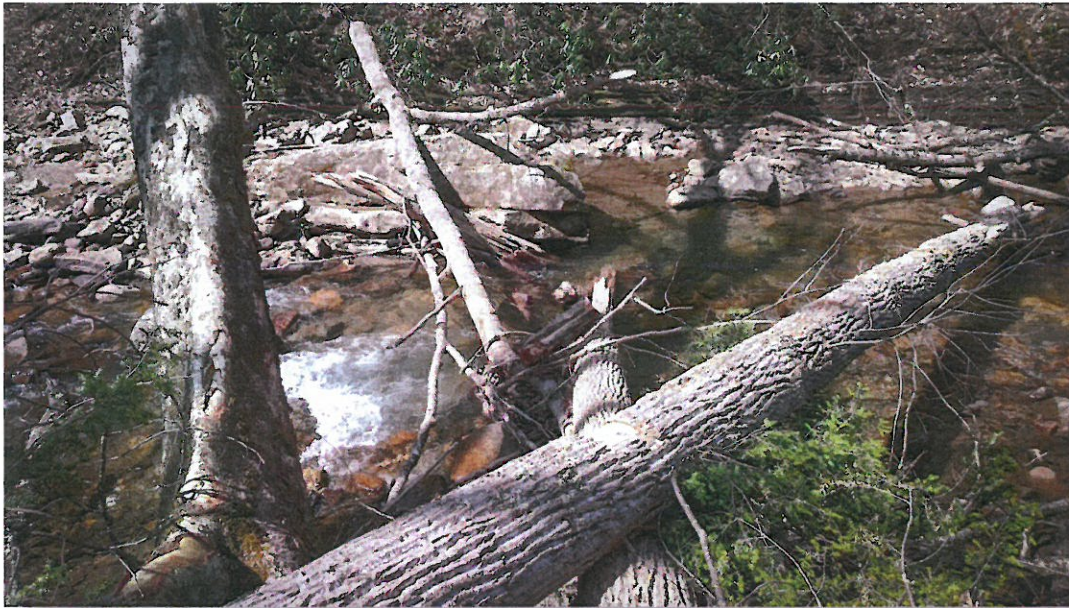
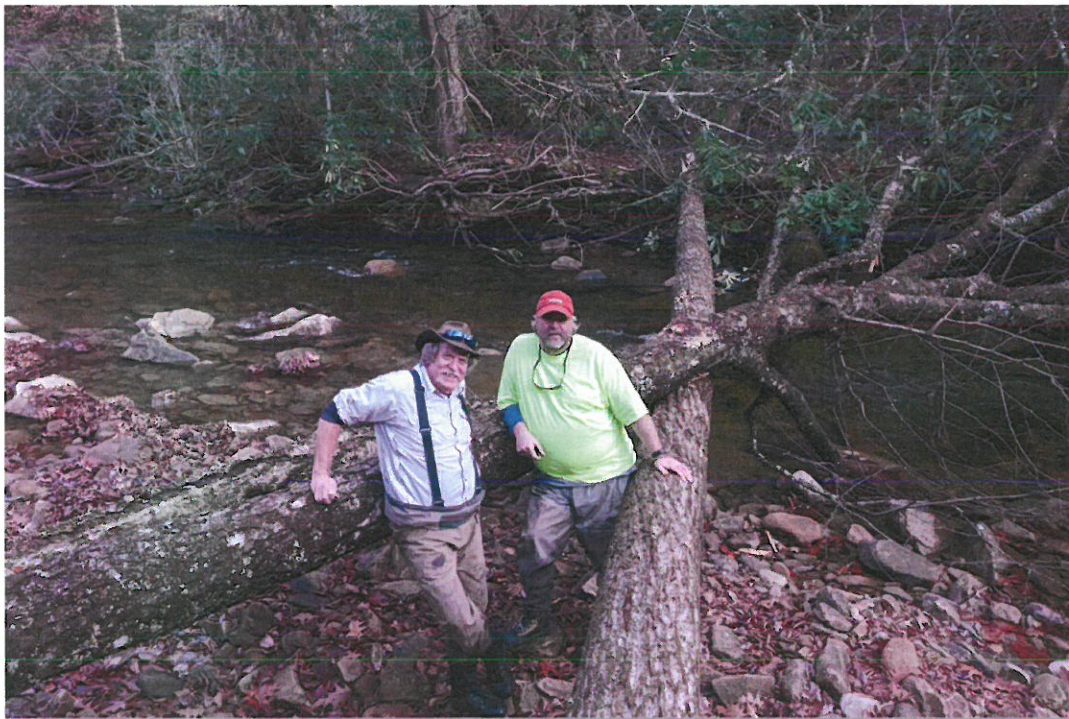
Felled log complexes (to provide overhead cover and recruit mobile wood)

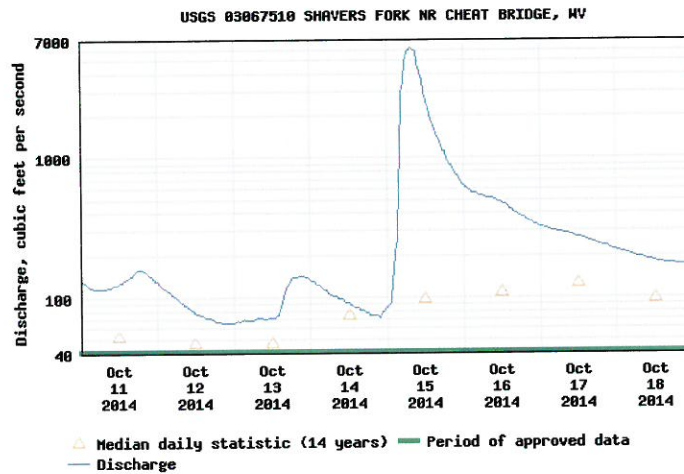
On the night of October 14th, 2014, Mill Creek experienced a significantly greater than bank full flood event just as the team's work had been completed. More than three inches of rain

fell in the watershed in less than six hours. During that event, water levels in some reaches of the Mill Creek mainstem rose more than 10 feet very rapidly. Although Mill Creek has no USGS gage, the October 2014 flood event can be seen on the Shaver's Fork of Cheat River gage at Cheat Bridge. The Shaver's Fork Watershed is adjacent to Mill Creek to the east at approximately the same latitude.

Discharge, cubic feet per second

Most recent instantaneous value: 19 09-18-2015 16:00 EDT

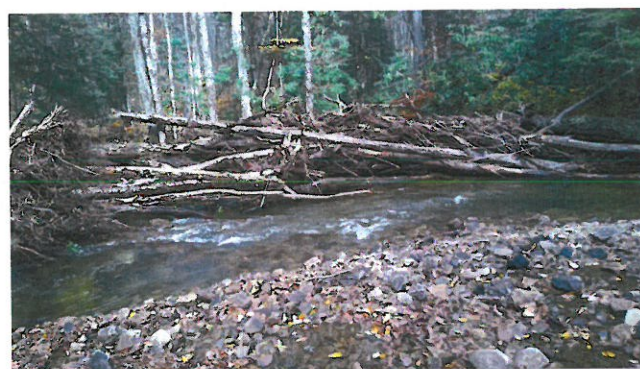
The effects of the flood event on the recently installed LWM structures were extreme. None of the installed wood had had time to saturate nor had the rock and cobble anchors had time to set or harden. No cabling or deadman anchors had been utilized as the team had chosen to keep the structures as natural as possible. The structures were at the most vulnerable stage in their life span and many succumbed to the force of the event. During late fall 2014 and early spring 2015, forensic evaluations by the restoration team confirmed that 27 of the 52 structures had been lost entirely. Several others were weakened but were retained. In all, 25 of the installed structures survived what had been an extreme test of their stability. As had been envisioned for a worst case scenario, much of the large wood that was mobilized from failed structures eventually added to other wood in downstream LWM complexes, both man-made and natural, and is continuing to enhance Brook Trout habitat in those locations, as can be seen in the image below.

In some ways, the October 2014 flood event was as fortuitous as it was unfortunate. Occurring as it did during the EBTJV project period that covered two successive construction seasons, it stress-tested the 2014 work and afforded an opportunity for the restoration team to rapidly incorporate modifications to the deployment of restoration practices during the remainder of the project period. Given that opportunity, the restoration team conducted forensic evaluations of both failed and surviving LWM structures during late fall 2014 and early spring 2015. Those evaluations yielded several conclusions that guided the restoration team going into the 2015 construction season. They included the following:

- Structures in stream reaches that had some adjacent flood plain often survived well
- Many of the failed structures had been installed too aggressively, i.e., they were an attempt to force too great a change in channel morphology

- There had been too much emphasis on speed of construction during the 2014 season, at the expense of durability; a more modest pace would allow better construction practices that could enhance structural stability and durability
