## 2013 Interim Performance Report

**Project Title:** EBTJV Connectivity Improvement: Removal of two dams in the Wetmore Run Watershed, Potter County, PA

**Date Prepared:** January 8, 2014

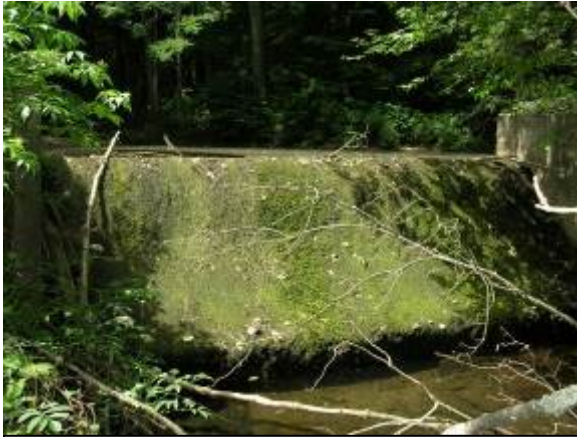
Photo 1 – looking upstream towards Right Branch Dam. credit: PFBC

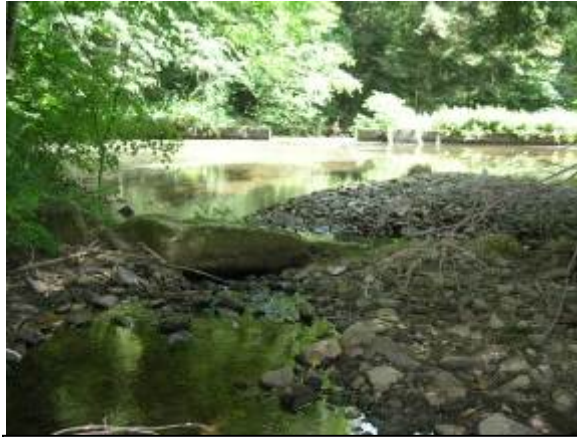
Photo 2 – looking downstream towards Right Branch Dam. credit: PFBC

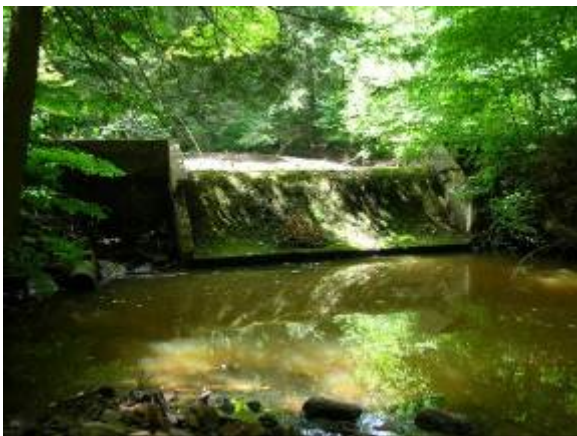
Photo 3 – looking upstream towards Left Branch Dam. credit: PFBC

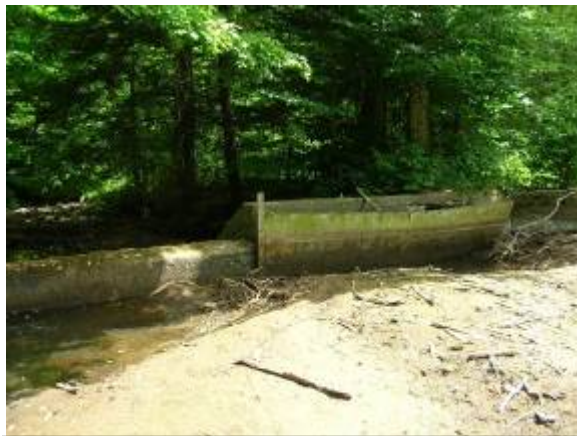
Photo 4 – looking downstream towards Left Branch Dam. credit: PFBC

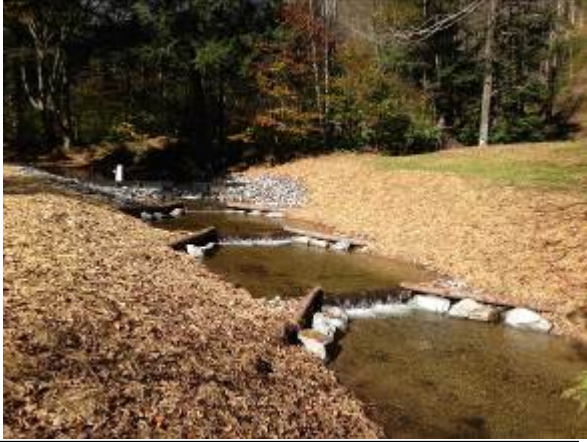
Photo 5 – Completed construction on Wetmore Run. credit: PFBC

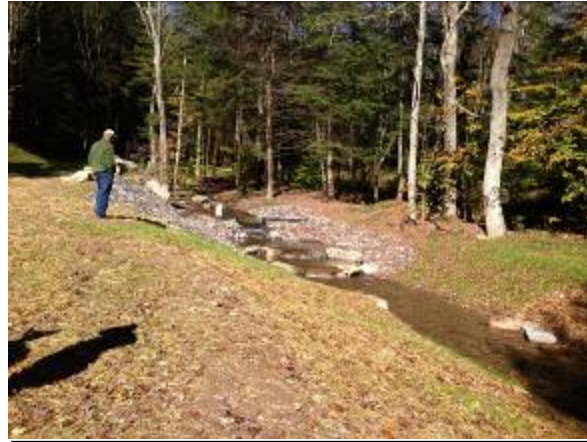
Photo 6 – Completed construction on Rt Br Wetmore Run. credit: PFBC

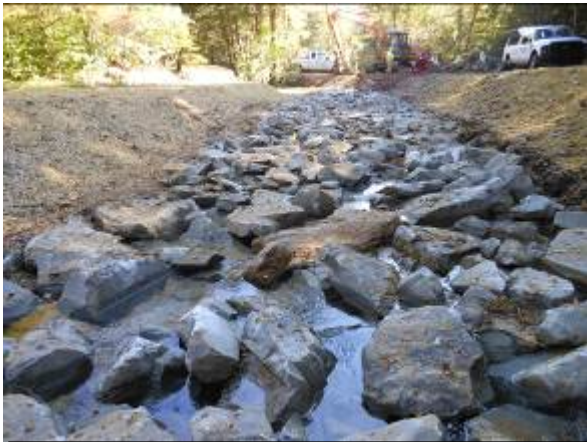
PFBC has two main concerns after the construction phase of the project. First, the flow through the infiltration galleries appears to be subsurface in some locations. The large rip rap used to armor the bottom of the stream channel creates large interstitial spaces. Through time these spaces should be "plugged" with stream bed material from upstream and the flow should be more surface oriented. Second, weirs were installed to monitor pass-by flows that will protect aquatic life by insuring that a

Photo 7 – Completed infiltration gallery. Note flow through interstitial spaces. Through time these should fill in with natural bed material. credit: PFBC

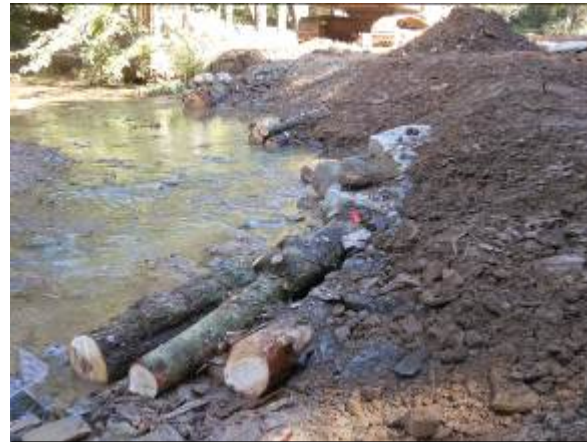
Photo 8 – Log vanes constructed to decrease pressure on the banks. credit: PFBC

PFBC discussed the possibility of utilizing onsite felled logs to implement habitat enhancement structures in Wetmore Run. GBA's contractor, Harger Utility Co, agreed to install several log and stone habitat structures in the vicinity of the former impoundments. PFBC Habitat staff met the construction crew onsite to discuss placement of the structures and sequencing of placing those structures.
