# Eastern Brook Trout Joint Venture

## Completed Project Report Form

**Project Title:** ‘Chop and Drop’ in the Sunday River, Maine: A NFHAP project for an EBTJV intact status subwatershed

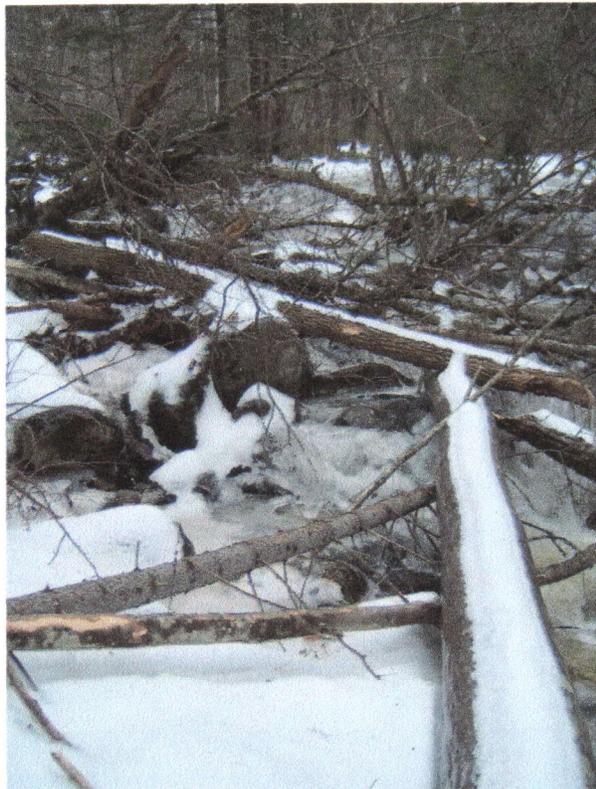
12/16/08. Chase Hill Brook  
after treatment with chop  
and drop. Photograph by Jeff  
Stern, Androscoggin River  
Watershed Council.

- **Methods used:** Initially, two half mile-long reaches of two Sunday River headwater tributaries were treated by adding coarse woody material. A nearby tributary was not treated and was used as a control. When two Bear River headwater tributaries were added to the study in December 2008, a half mile reach of each stream (Branch Brook and Chase Hill Brook) was treated by adding coarse woody material.

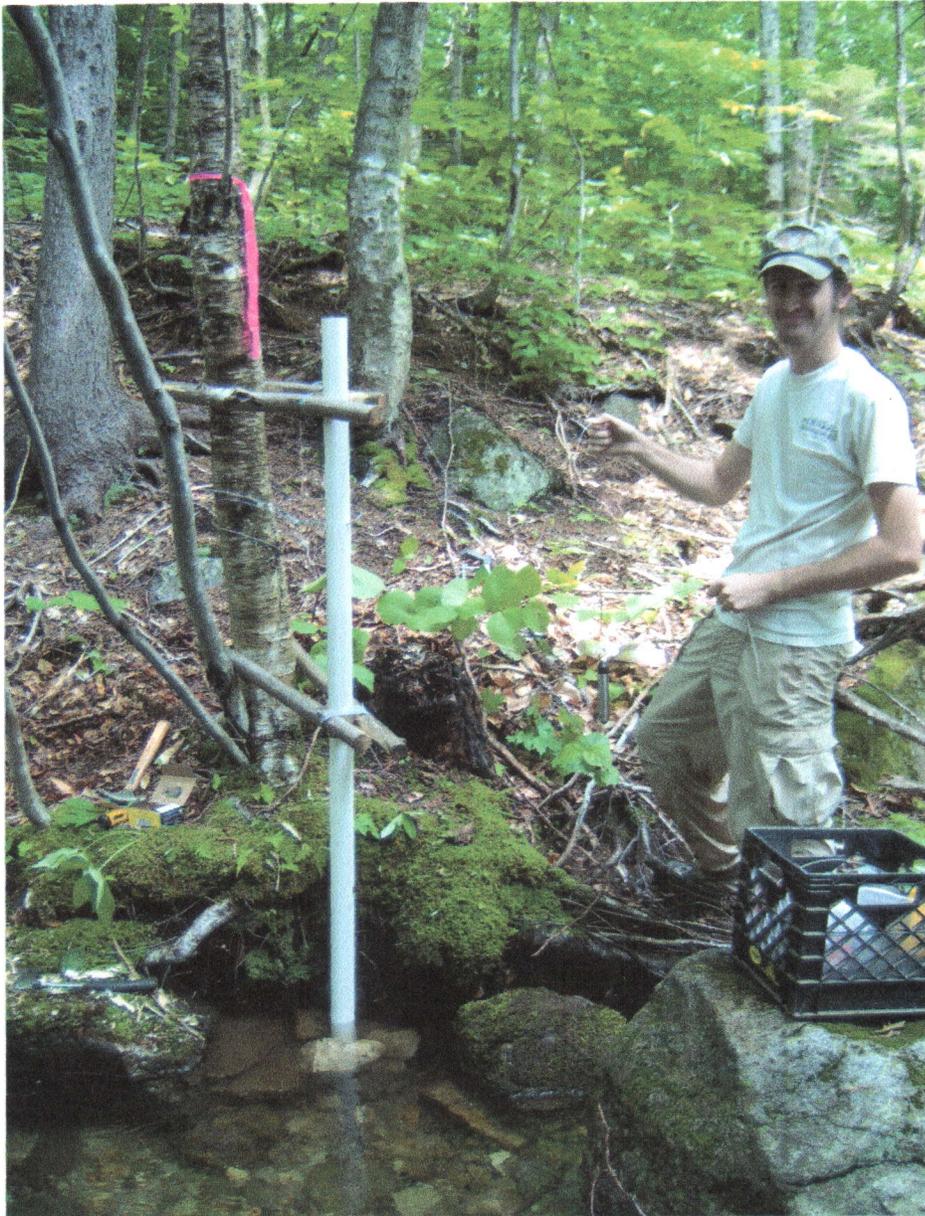
6/27/08. Installation of a stilling well for a water level logger, Sunday River treatment site #2 above chop and drop area. Photograph by Jeff Stern, Androscoggin River Watershed Council.

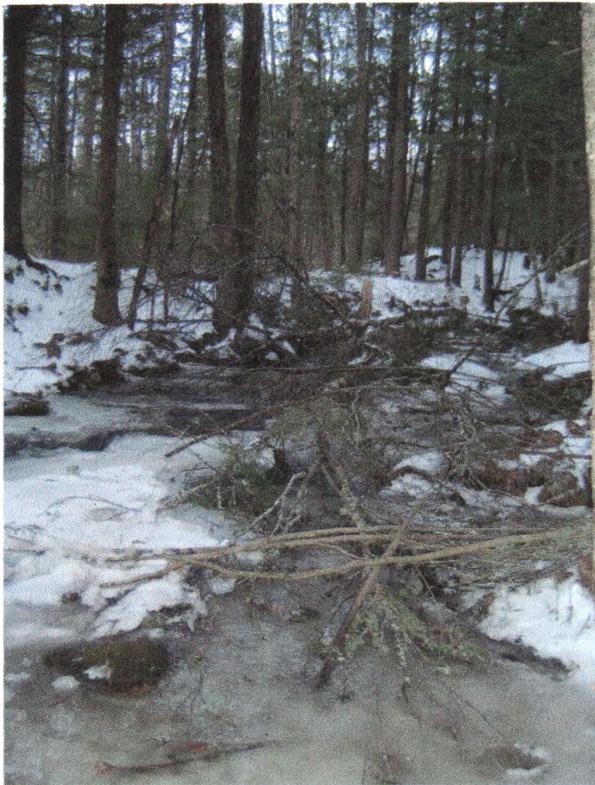
12/16/08. Branch Brook from similar vantage point as the above photo after treatment with chop and drop.
