## **Connecticut River Aquatic Habitat Connectivity**

## Fish Passage in the White River Watershed

Marsh Brook on North Hollow Road, Rochester Vermont

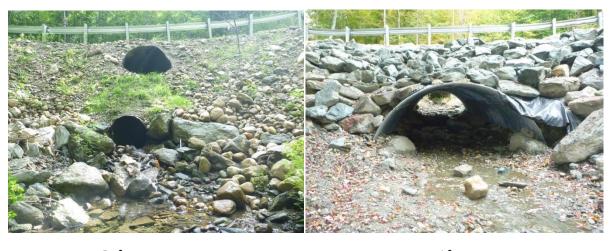
Before After

**Left:** A view of the Marsh Brook culvert outlet on North Hollow road showing two undersized culverts with minimal fish or aquatic organism passage. **Right:** New Marsh Brook culvert at the North Hollow road crossing designed for fish and aquatic organism passage as well as flood resiliency.

<u>Problems / history:</u> Multiple culverts in Rochester Vermont were in need of emergency repair following the flooding from tropical storm Irene in August of 2011. Following tropical storm Irene many of the emergency fixes were designed to quickly open roads for vehicle traffic, but not always allow for fish and aquatic organism passage. Working closely with FEMA and the town of Rochester the US Fish and Wildlife Service has provided technical assistance, engineering designs, and project over site to ensure projects allow both fish and aquatic organism passage.

<u>Site description:</u> Marsh Brook in Rochester Vermont is a headwater tributary to the White River and supports a thriving fishery including Atlantic salmon and a wild brook trout population. This new culvert will allow native brook trout to access the entire headwaters which contain critical thermal refugia and spawning habitat.

<u>Fish and AOP Passage:</u> Before culvert replacement began fish biologists from the US Fish and Wildlife Service captured and marked fish downstream from the culvert with a fin clip. Just three weeks after the new culvert was installed biologists returned and found that over half of the brook trout collected in the first 100ft upstream from the culvert had a fin clip showing that they had passed through the culvert.
