## Eastern Brook Trout Joint Venture Completed Project Report Form

**Project Title: Restoring habitat connectivity in Machias and Saint Croix River tributary streams, ME: EBTJV&NFHAP; F14AC00403**

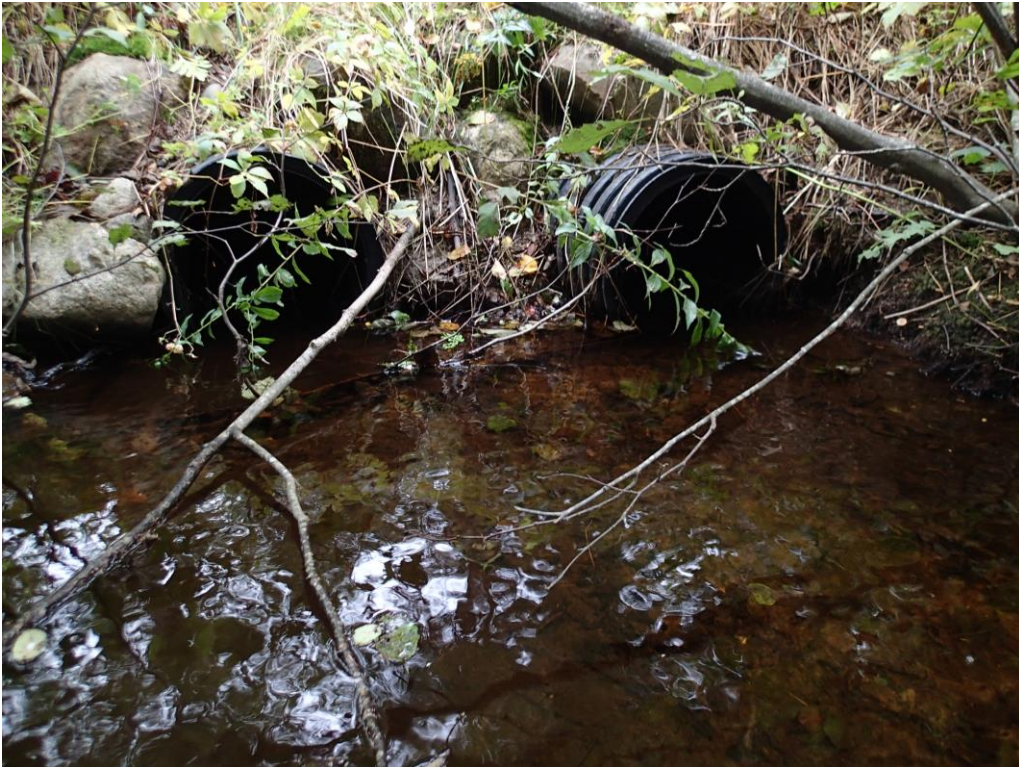
Billy Brown Brook at Shaw Street crossing prior to arch culvert installation in 2014.

DLLT and partners removed six culverts that were acting as fish passage barriers and replaced them with bankfull-spanning open bottom structures. The structures included three steel arches (12', 18', and 20'), one concrete arch (8'), and two concrete-decked bridges

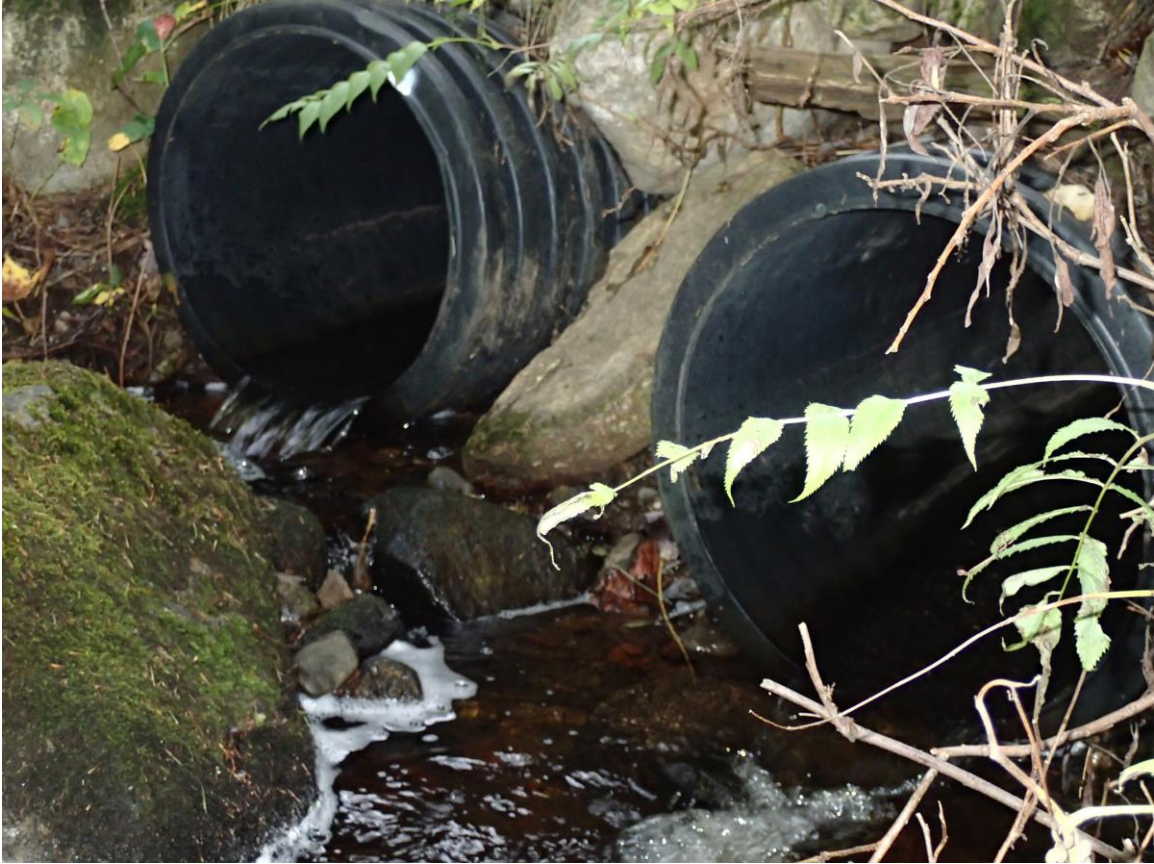
Outlet at Billy Brown Brook – Shaw Street crossing.

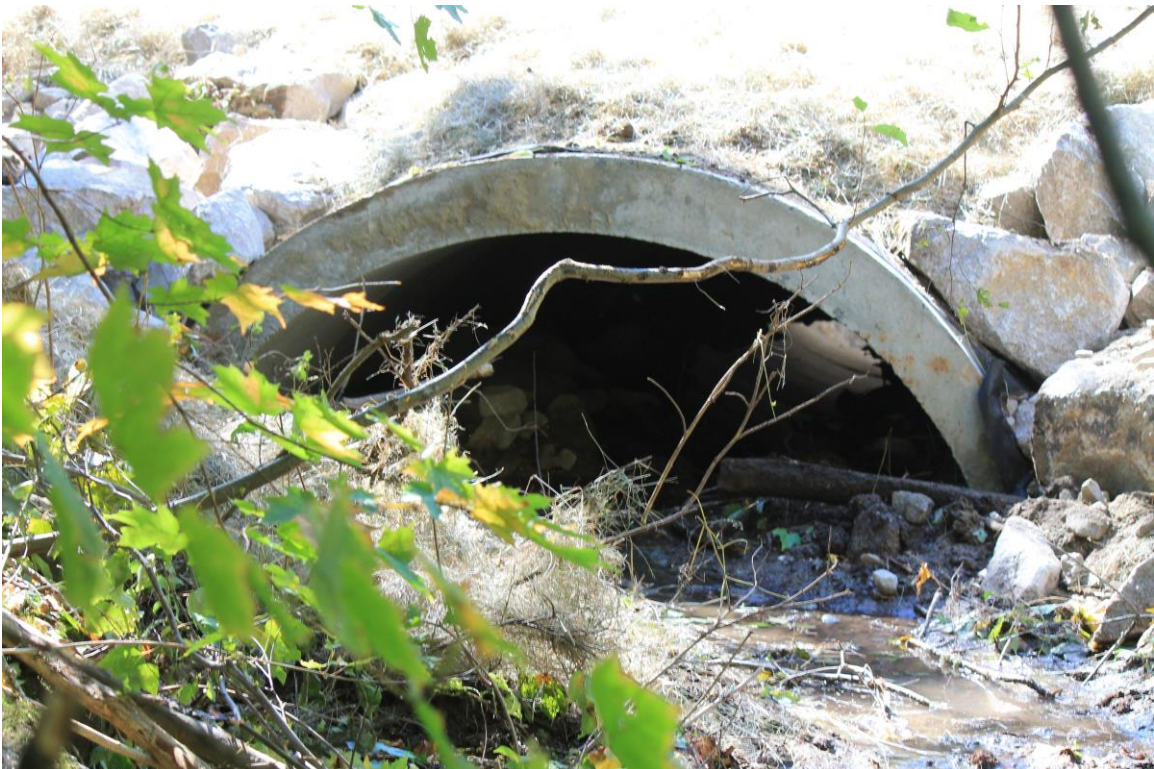
Billy Brown Brook at Shaw Street crossing after arch culvert installation in 2014.

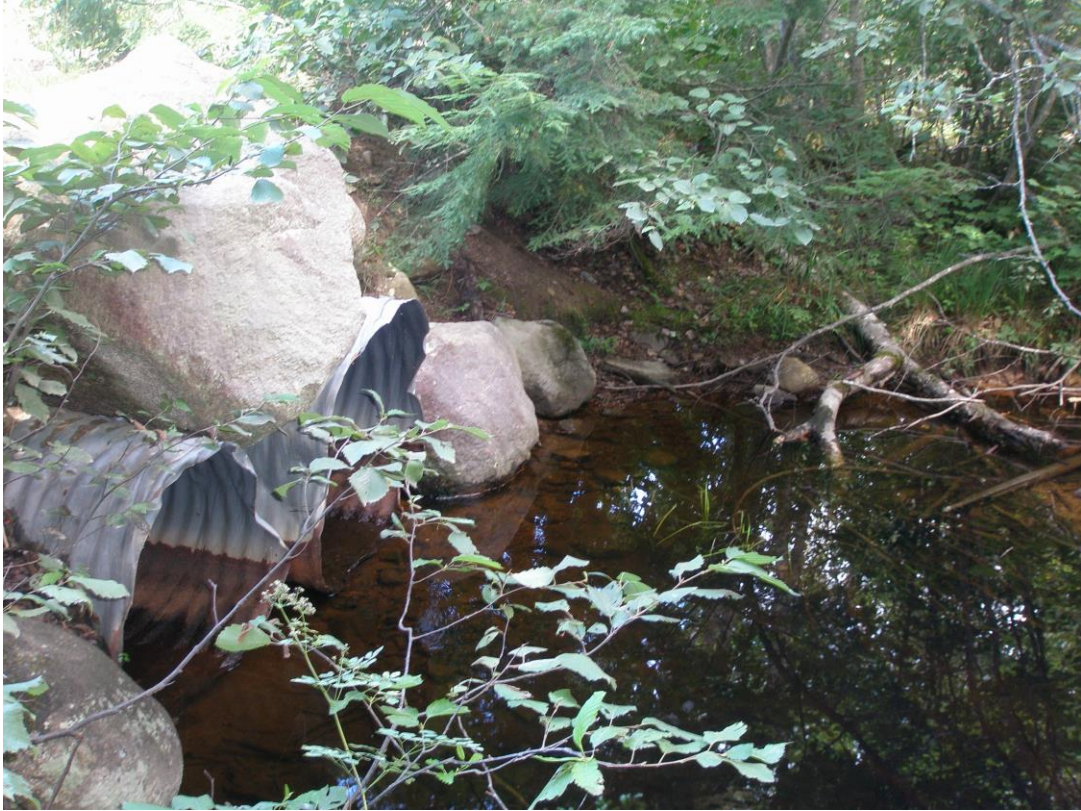
South Branch of Little River before restoration:  
downstream.

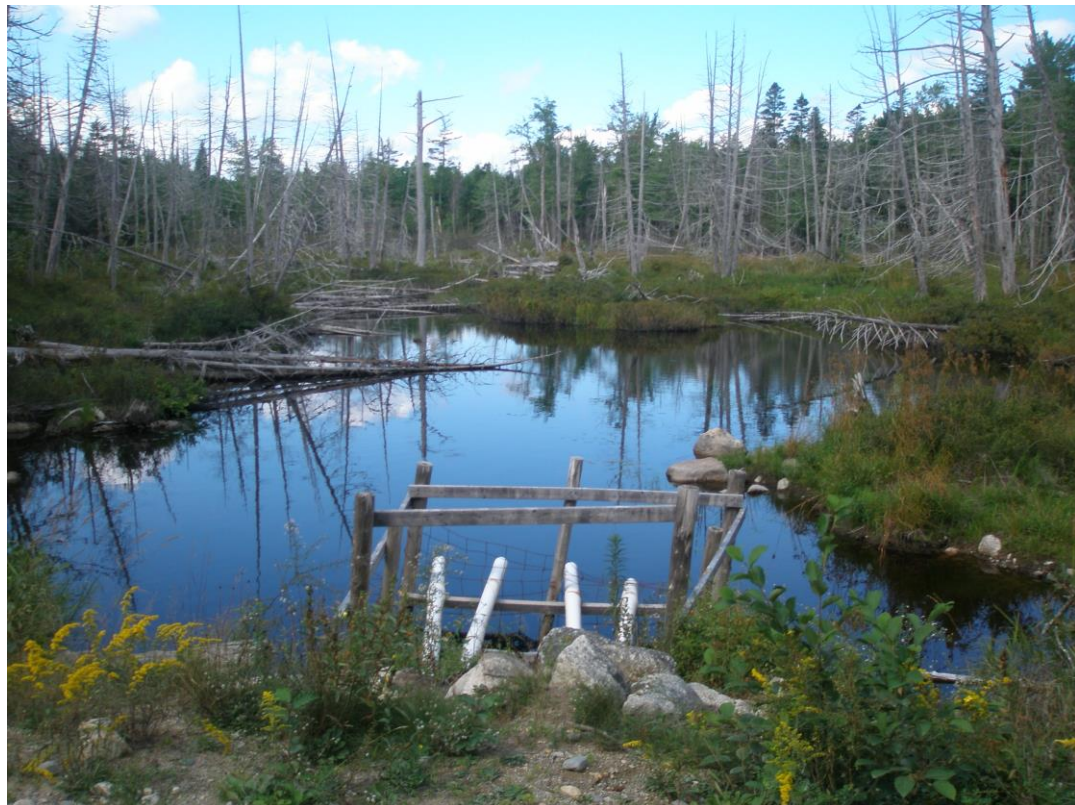
Deadwater upstream of South Branch crossing.

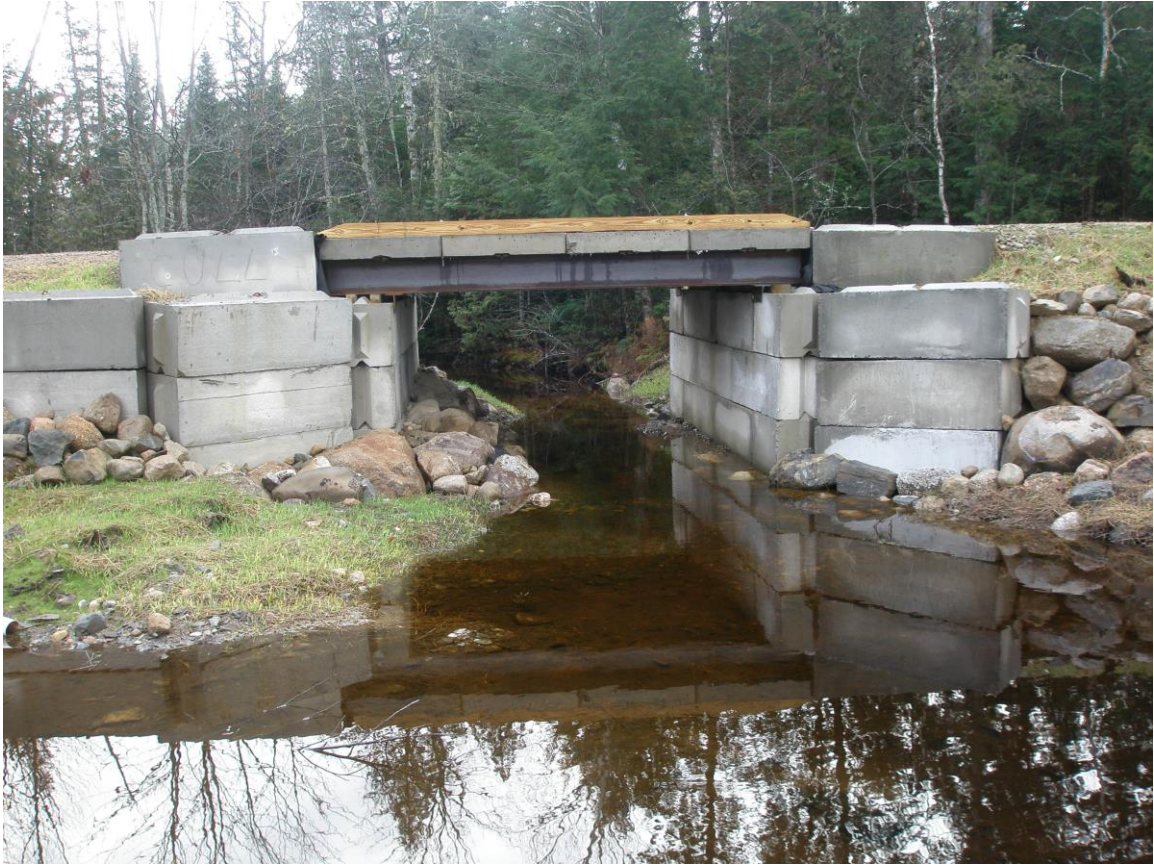
Concrete-decked bridge installed at South Branch crossing.

NRCS funding received after the EBTJV grant award was sufficient to fully fund restoration at the two sites with bottomless arch culverts installed. This allowed for two sites on tributaries of the Little River to be restored. Costs at these sites were reduced further by constructing concrete-decked bridges rather than steel or concrete arches. As a result, 6 sites were restored using this EBTJV grant rather than the 4 originally anticipated.

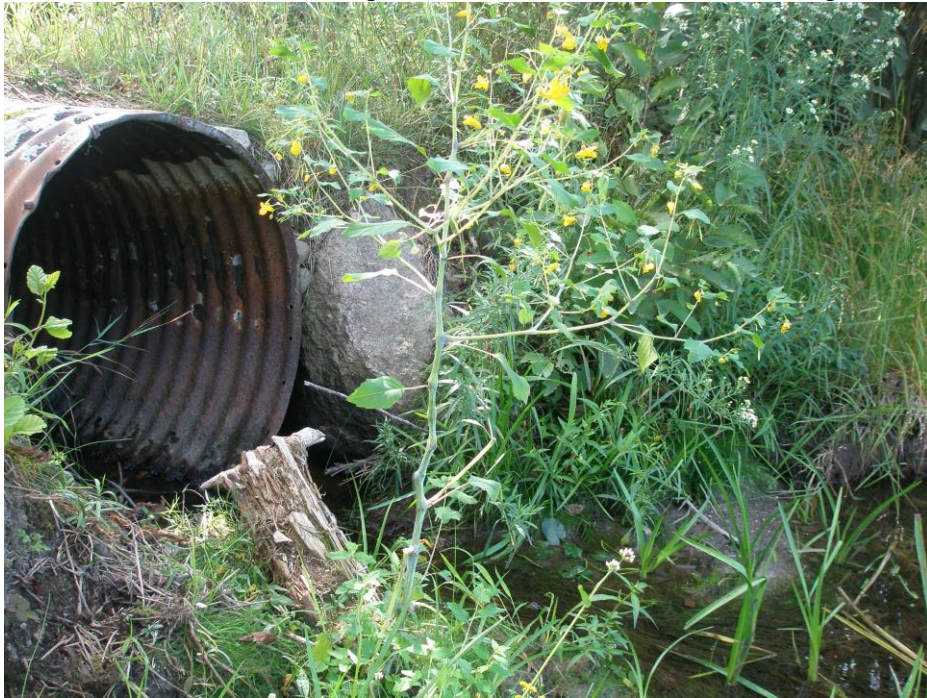
Downstream of Towers Brook crossing.

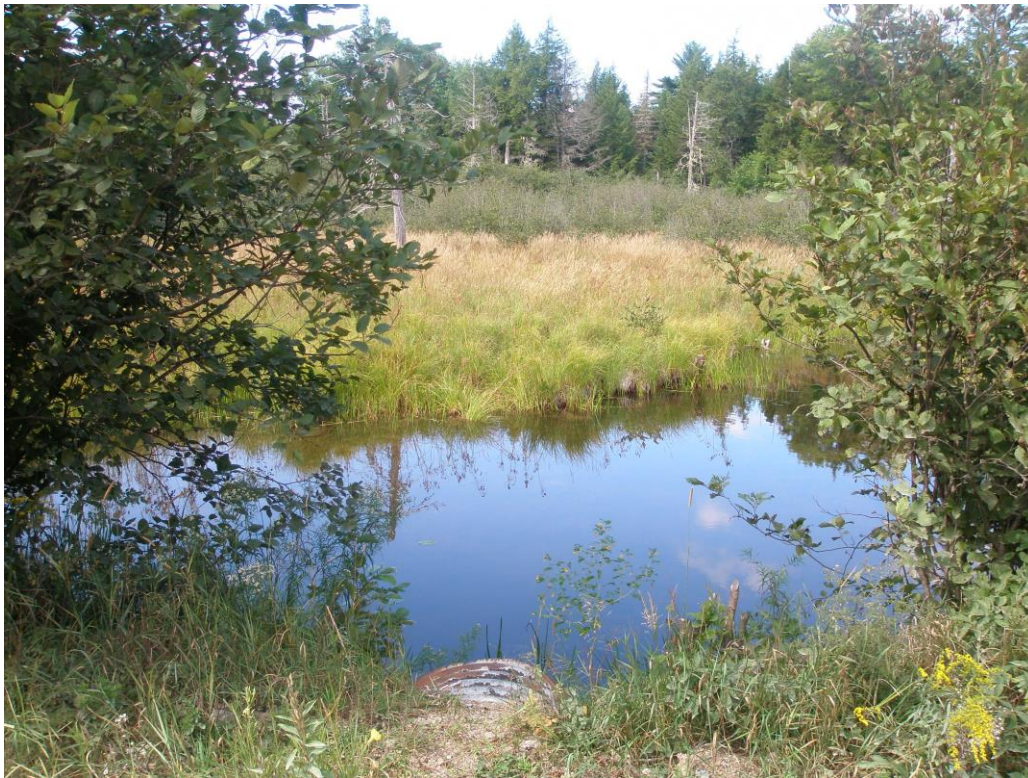
Deadwater upstream of Towers Brook crossing.

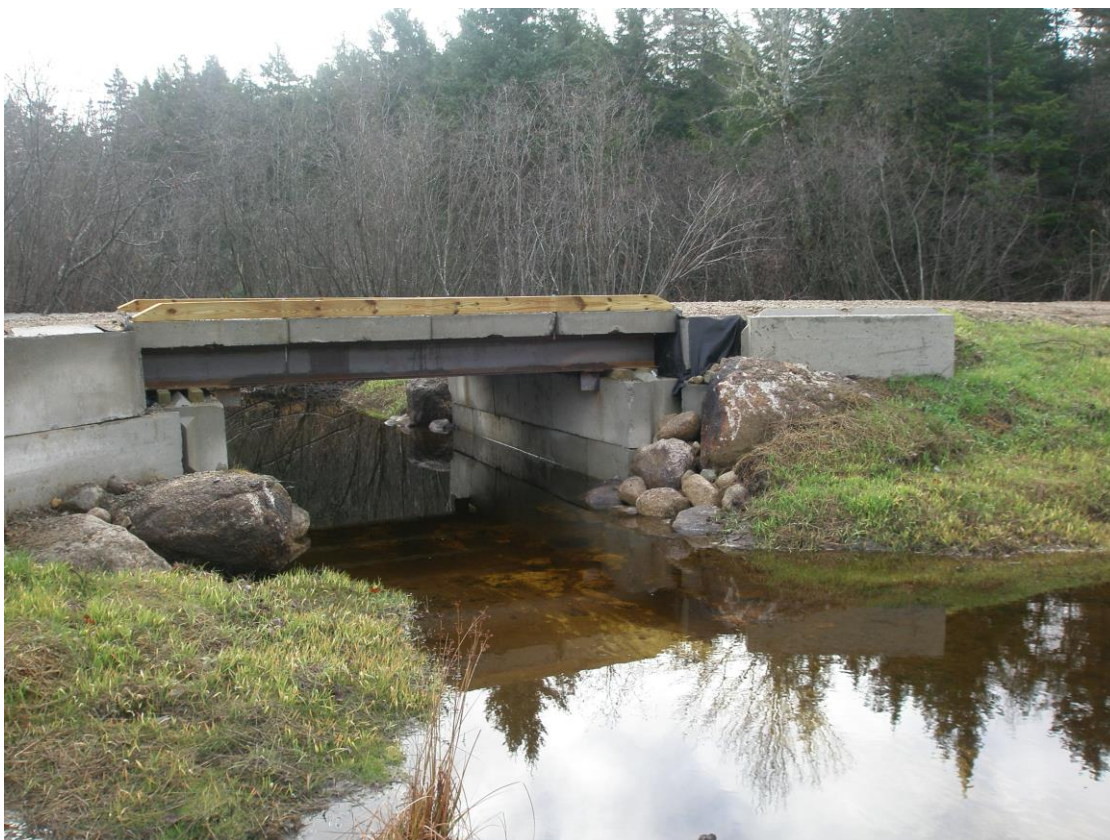
Concrete-decked bridge installed at Towers Brook crossing.

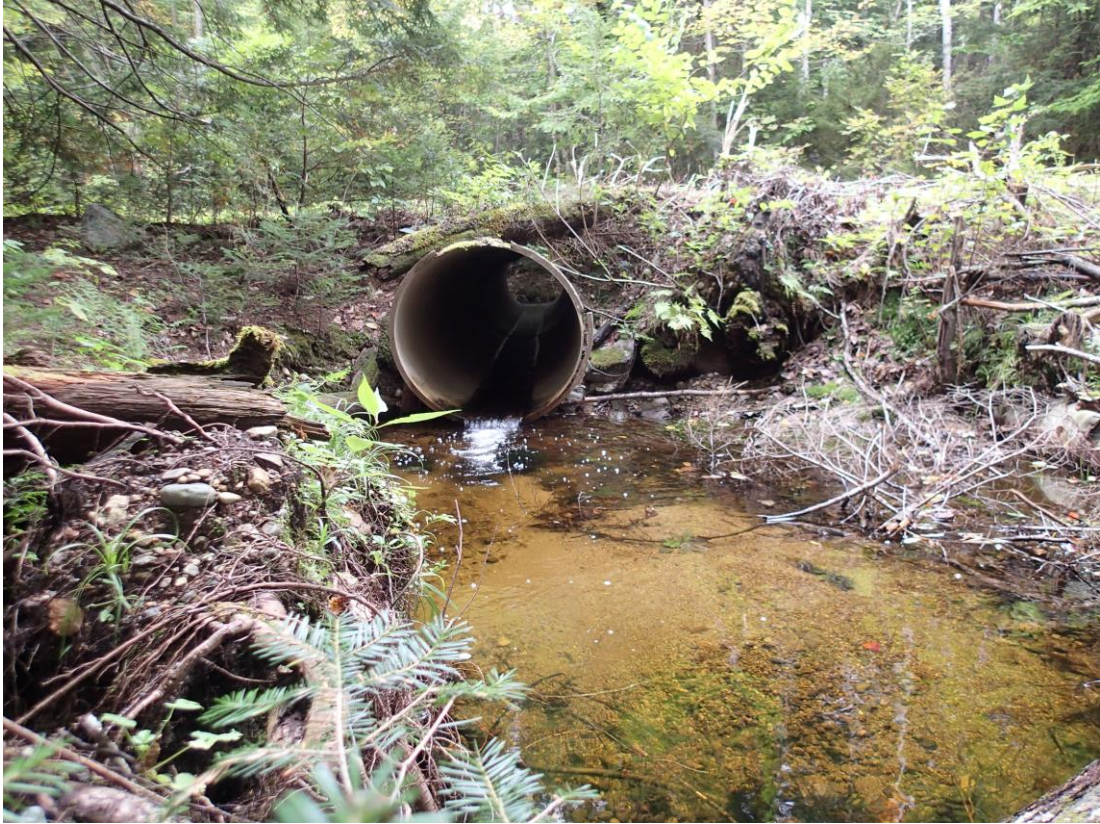
Outlet at Fourth Lake Trib.

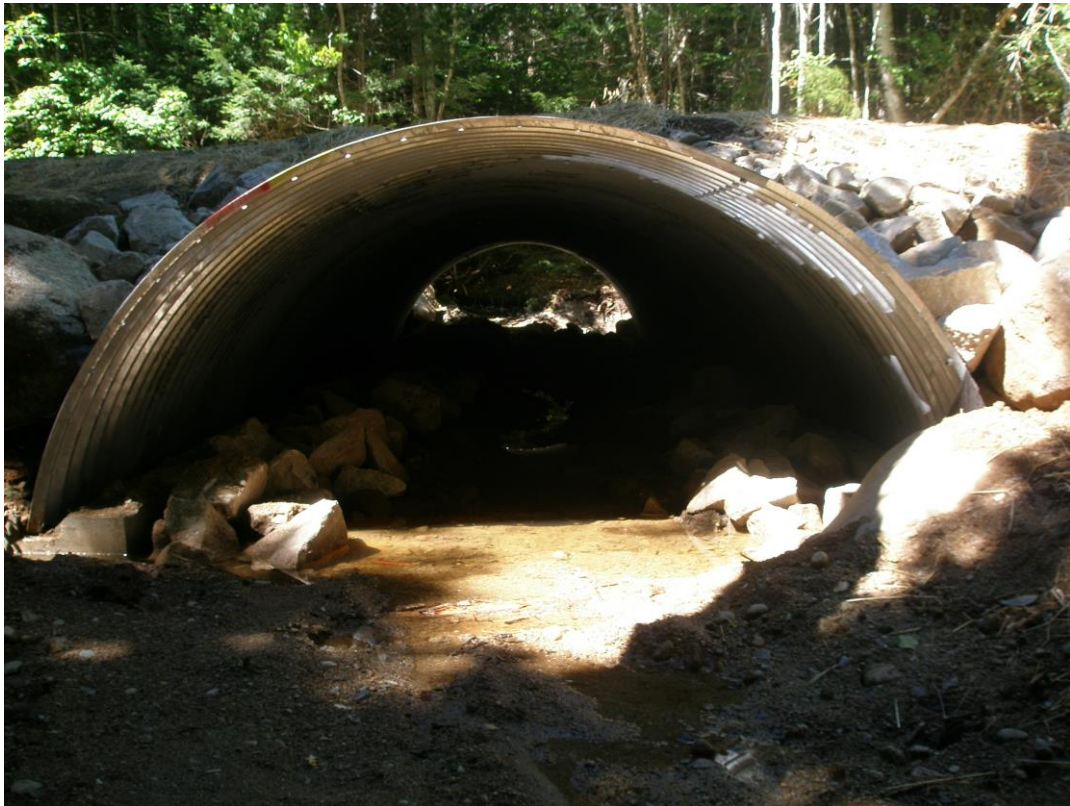
Fourth Lake Trib. after arch culvert installation during 2016 drought.

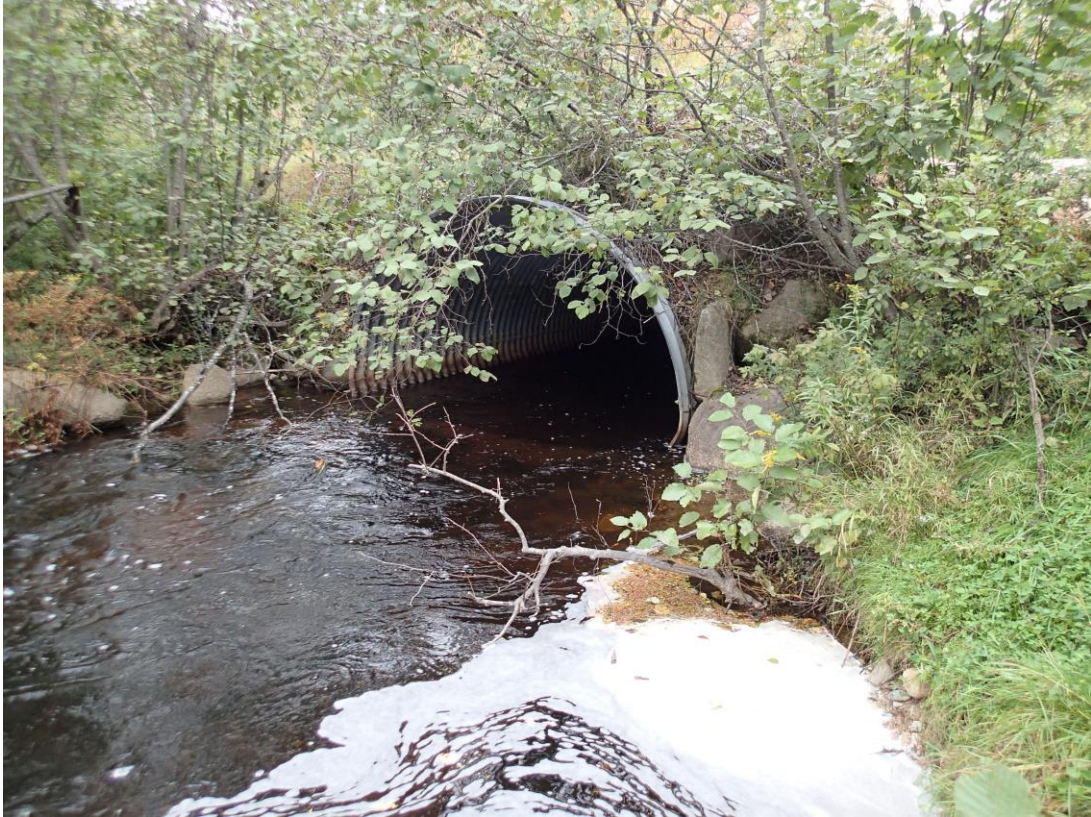
Outlet of Grand Lake Brook crossing (before).

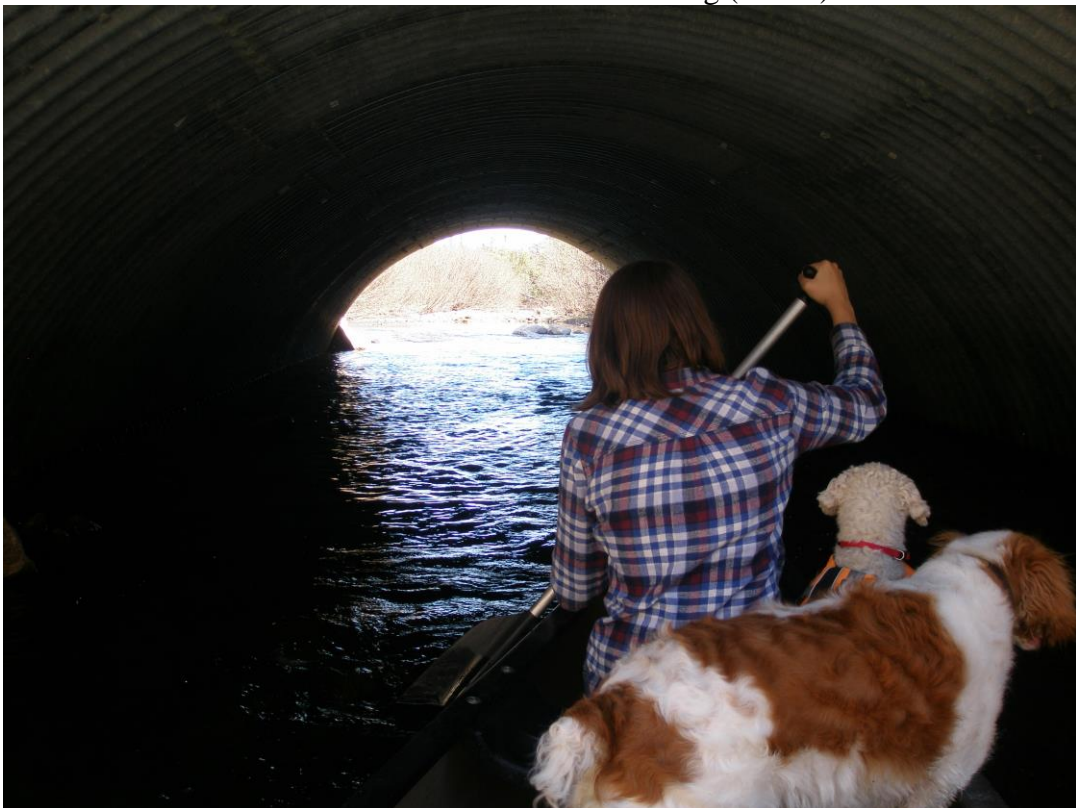
Paddling a canoe through Grand Lake Brook 20' arch culvert (after).

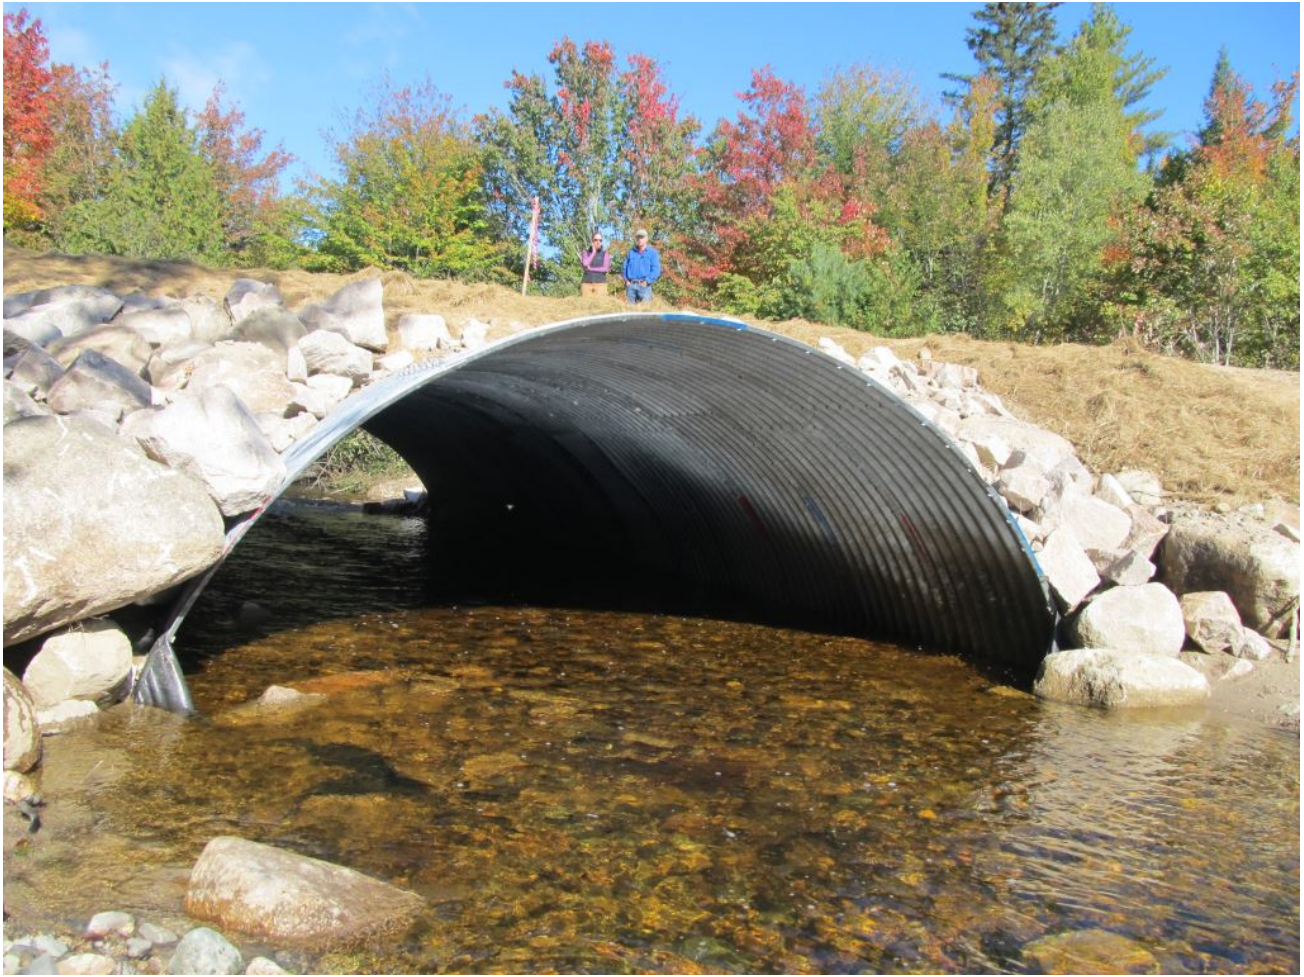
Grand Lake Brook (after)
