## Eastern Brook Trout Joint Venture Completed Project Report Form

**Project Title:** Culvert Replacement and Stream Restoration in Wolfden Run, Garrett County, Maryland

# Wolf Den Aquatic Organism Passage Project NFPP FY20

### Final Report to The United States Fish and Wildlife Service

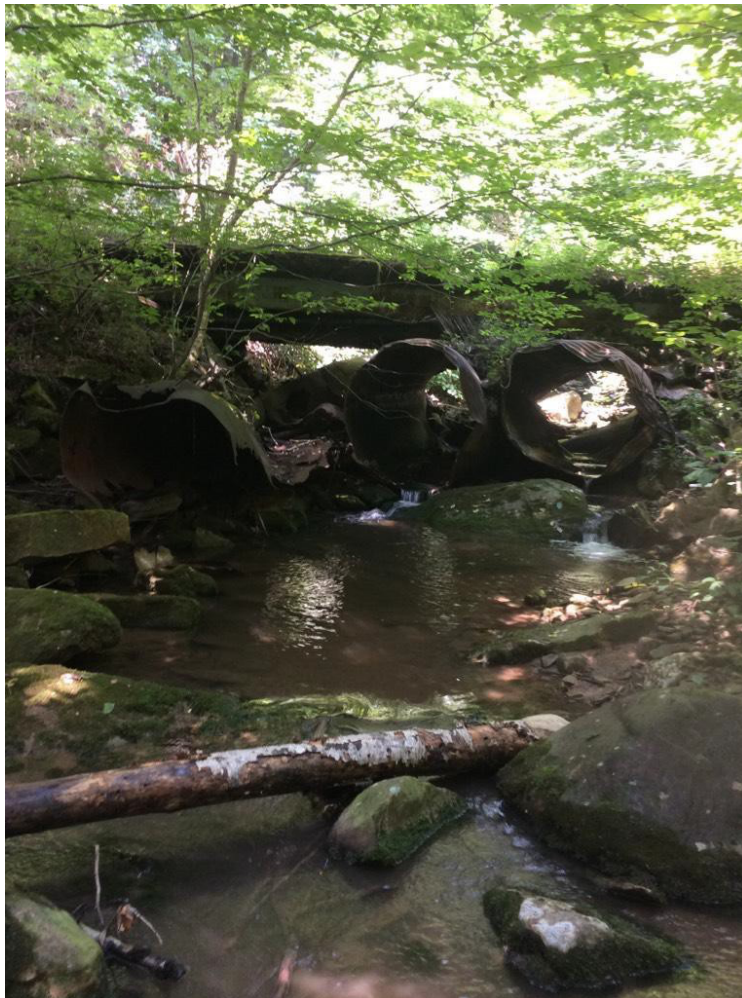
Before:

Located on Wolf Den Run, the AOP barrier mitigation project was designed to replace a currently failing road stream crossing. The installation of a bridge was intended to improve recreational opportunities within Wolf Den Run State Park, allowing visitors increased fishing, bird watching, and hiking access. Previous conditions at the road stream crossing prevent access for park goers and for management staff responsible for visitor safety. The replacement bridge will ensure access while reconnecting 2.8 miles of headwater habitat.

In June of 2020, TU successfully procured a construction contractor, Carl Belt Inc. of Cumberland, MD, to remove the existing structure and replace it with a prefabricated bridge manufactured by ADM Welding. USFWS Partners for Fish and Wildlife provided technical assistance to MD DNR engineering staff who was the lead designer on the project. Collaborative efforts ensured construction designs adequately spanned the stream and allowed for natural stream process/fish movement. At the MD DNR's request for third party stamping, TU's procurement involved Carl Belt's subcontracting of Bennett, Brewer and Associates of Frostburg, MD to stamp the final designs. The prefabricated bridge/concrete abutments were installed in August and September of 2020 with construction completed on 9/8/2020. All necessary permits were in place prior to construction.

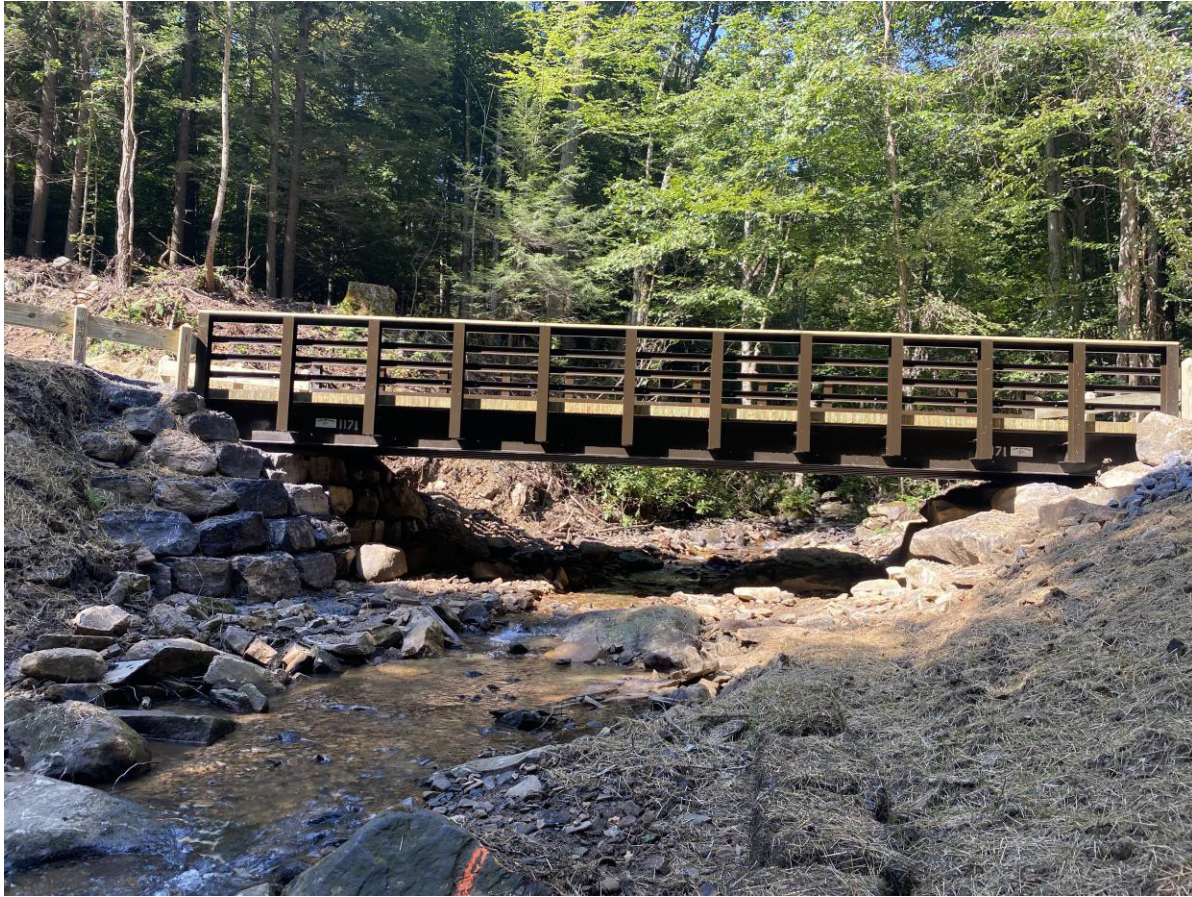
After:

Despite the discovery of an additional barrier limiting brook trout movements in Wolf Den Run, TU views the fully completed project as a success. The passage barrier was effectively removed at the project location. The current structure is now in use and allows park visitors access as intended. TU is now aware of the additional barrier and is taking active steps to address additional resource concerns in the watershed.

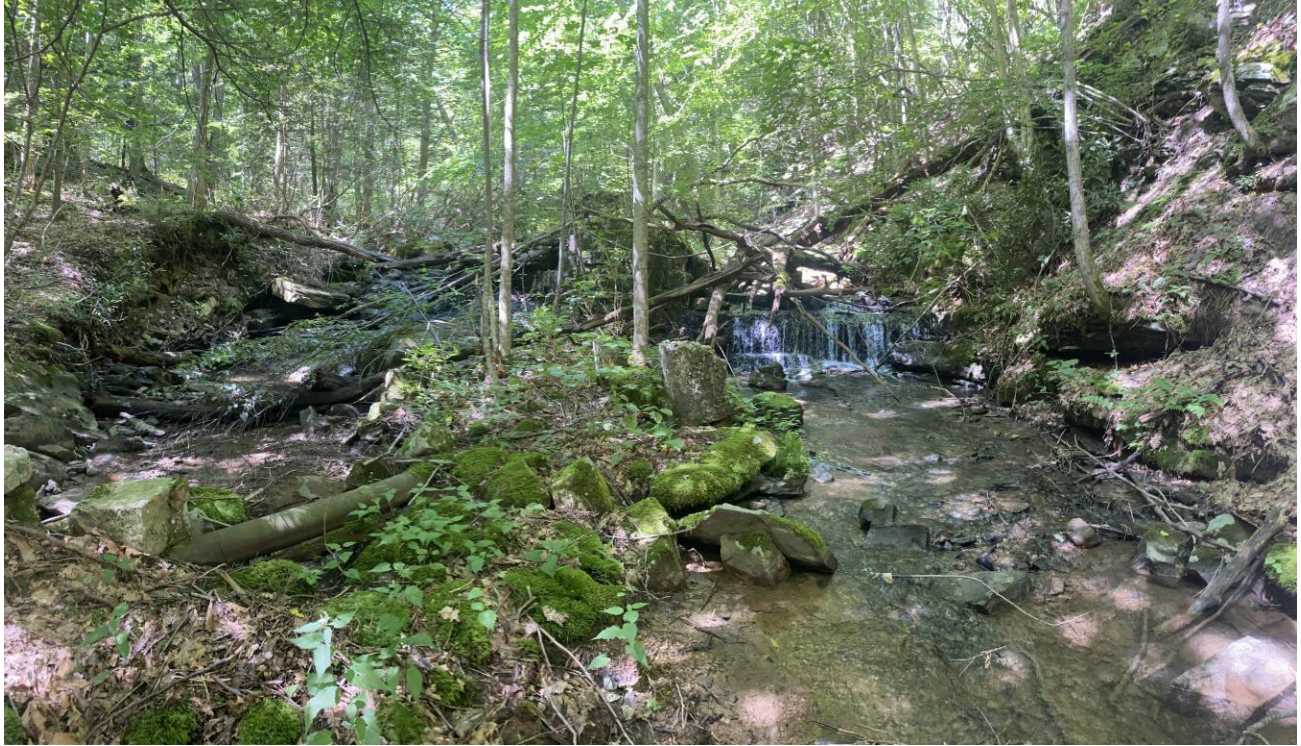
Newly discovered dam –

To diagnose the cause of brook trout absence, TU extended visual searches for movement barriers downstream into an area that was previously inaccessible (private property) when original culvert surveys were completed. Additional searching for stream blockages revealed an abandoned and previously unknown concrete and stone dam downstream. The dam represents a clear AOP barrier as the dam's concrete base was constructed atop bedrock, creating fast, shallow conditions just downstream of the relic impoundment (see photo below). Due to the shallow staging area, it is unlikely that brook trout can easily overcome the vertical drop. TU enlisted MDDNR staff to conduct qualitative fisheries samples upstream and downstream of the abandoned dam. Brook trout were found in abundance below the dam with only one individual observed upstream.

In 2020, TU also deployed continuous pH loggers upstream of the to be replaced structure and below the newly discovered impoundment. Wolf Den Run is known to experience reduced water quality stemming from upstream acid mine drainage. However, as mentioned above, ongoing fisheries monitoring indicates stable brook trout populations at several downstream monitoring stations. The purpose of pH logger deployment was to determine whether low pH thresholds are exceeded in upstream reaches above the replacement culvert but through dilution in a downstream direction are not exceeded where brook trout have been commonly observed. The data revealed nearly identical minimum and maximum pH values above the to be replaced culvert and below the newly discovered dam, suggesting that pH is not the limiting factor. Personal communication with MD DNR staff indicates that water quality in Wolf Den Run was considerably poorer in previous decades when mining was more active. Consequently, brook trout populations may have been extirpated from upstream reaches. One possible explanation for the absence of brook trout is that, following water quality improvements, brook trout were unable to effectively recolonize areas upstream due to the presence of the newly discovered dam.

Because the dam appears to be playing significant role in limiting upstream recolonization, TU is currently working to obtain additional funding through the National Fish Passage Program (NFPP) for the removal of the abandoned structure. In support of the project, TU has secured assistance from MD DNR for survey and design and plans to submit a 2022 application for NFPP funds.
